Warning Message "Vehicle Electrical System Faulty" in Conjunction With Fault Memory Entry "Cell Module X, Ageing Detected" in the High-Voltage Battery Control Unit - BMC (44/25)

Model Line: **Taycan (Y1A / Y1B / Y1C)**

Model Year: **As of 2020 up to 2024**

Concerns: **Cell block module for high-voltage battery (battery module)**

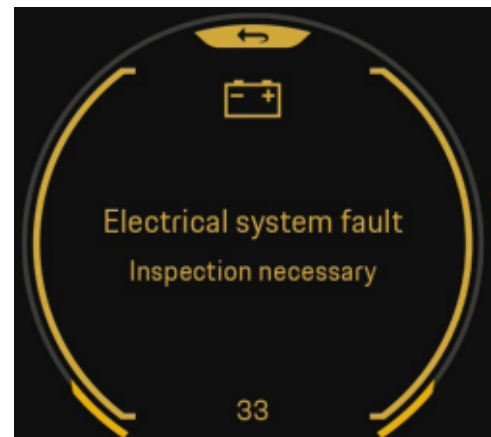
Warning message

If the high-voltage battery is abnormal, the following warning message will be displayed on the instrument cluster. ⇒ *Warning message*

In addition, the charging capacity of the high-voltage battery is automatically limited to 80% and the fault memory entry specified below is stored once or several times in the high-voltage battery control unit (BMC):

- B1D9EF* - Cell module x, ageing detected

Action: Identify and replace affected battery modules.
To do this, proceed as follows:

- Check in **PCSS** whether there are already **Workshop Campaigns for replacing individual battery modules**.
- **Create a PRMS ticket to Technical Support - Technical Request** and have a **comprehensive technical analysis performed**.
- Replace **identified battery modules**.

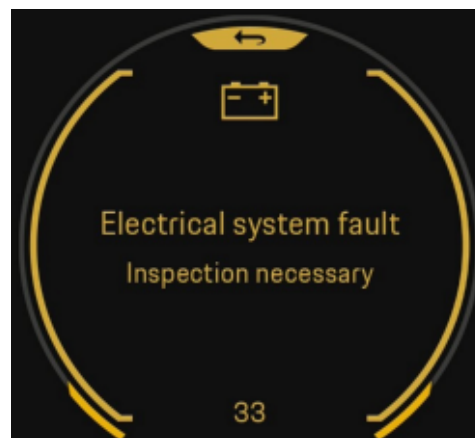
Illustration 2 Yellow warning message after identification of a cell module error

- The previous external **monitoring via VALs is omitted after** performing the **software update.**
- In the event of anomalies on the high-voltage battery, the **yellow warning message "Vehicle electrical system faulty"** will be displayed in the **instrument cluster** in the future. ⇒ *Illustration 2 Yellow warning message after identification of a cell module error*
- At the same time, active **fault codes (DTCs)** are stored in the high-voltage battery control unit.
- Even in the case of **repairs already carried out in the past**, the message can **appear again** if **other cell modules are affected.**

- If **abnormal battery modules** are diagnosed, the **warning message "Vehicle electrical system faulty" appears every time the vehicle is started (ignition change)** – until the **vehicle is diagnosed** in the Porsche Center and **repaired** if necessary.
- For **each cell module affected a separate fault code (DTC)** is stored in the **control unit of the high-voltage battery.** ⇒ *Illustration 3 Relevant error codes incl. affected module*
- Fault memory entry: B19D9EF*

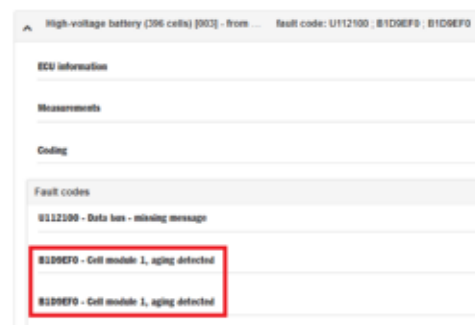
Illustration 3 Relevant error codes incl. affected module

At this point '*', different **numbers from 1 to 9** or different **letters from A to Z** can be specified, depending on the module number concerned. An example with warning module 1 is shown in Illustration 3.
