**Warning Message "Vehicle Electrical System Faulty" in Conjunction With Fault Memory Entry "Cell Module X, Ageing Detected" in the High-Voltage Battery Control Unit - BMC (44/25)**

Model Year: **As of 2020 up to 2024**

Model Line: **Taycan (Y1A / Y1B / Y1C)**

Concerns: **Cell block module for high-voltage battery (battery module)**

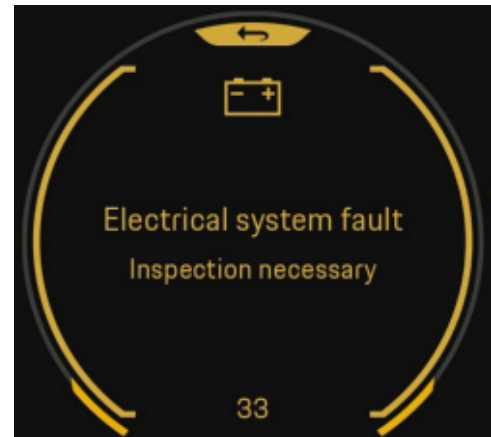
If the high-voltage battery is abnormal, the following warning message will be displayed on the instrument cluster. ⇒ *Warning message*

In addition, the charging capacity of the high-voltage battery is automatically limited to 80% and the fault memory entry specified below is stored once or several times in the high-voltage battery control unit (BMC):

- If the high-voltage battery is **not tested and repaired in the Porsche Center within 180 days**, the **charging capacity is automatically limited to 50%**.

- **As soon as a corresponding warning occurs, a Porsche Center is to be contacted immediately.**

Action: Identify and replace affected battery modules.  
To do this, proceed as follows:

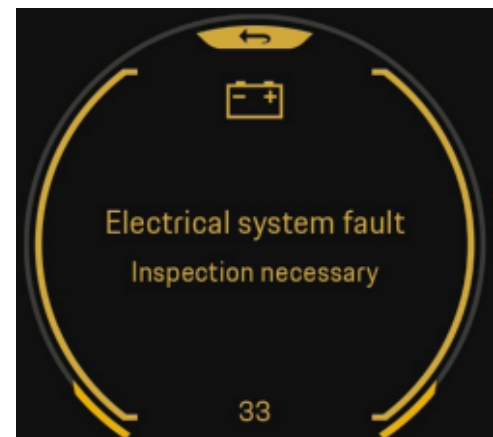
*Illustration 2 Yellow warning message after identification of a cell module error*

- If abnormalities in the battery modules are detected, the **warning message "Vehicle electrical system faulty" appears every time the vehicle is started (ignition change)** – until the **vehicle is diagnosed** in the Porsche Center and **repaired** if necessary.
- For **each cell module affected**, a **separate fault code (DTC)** is stored in the **control unit of the high-voltage battery**. ⇒ *Illustration 3 Relevant error codes incl. affected module*
- Example Fault memory entry: B19D9EF\*

- The warning message automatically limits the maximum charging capacity to 80% to reduce the risk of a short circuit in the battery.
- If, within 180 days, no testing or repair is carried out in the Porsche Center, the charging capacity is further reduced to 50%.

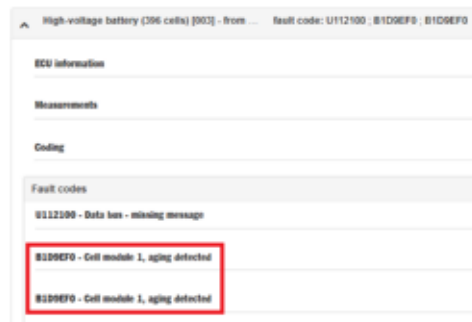
Illustration 3 Relevant error codes incl. affected module

At this point "\*", different **numbers from 1 to 9** or different **letters from A to Z** can be specified, depending on the module number concerned. An example with warning module 1 is shown in Illustration 3.
