## Technical product information

<b>Topic</b>	Panorama Sliding Sunroof - Creaking Noise from Rear Rail Area   Flying Spur
<b>Market area</b>	Bentley: worldwide (2WBE),China 796 VW Import Comp. Ltd (Vico), Beijing (6796)
<b>Brand</b>	Bentley
<b>Transaction No.</b>	2081987/1
<b>Level</b>	EH
<b>Status</b>	Released for publishing
<b>Release date</b>	May 18 2026

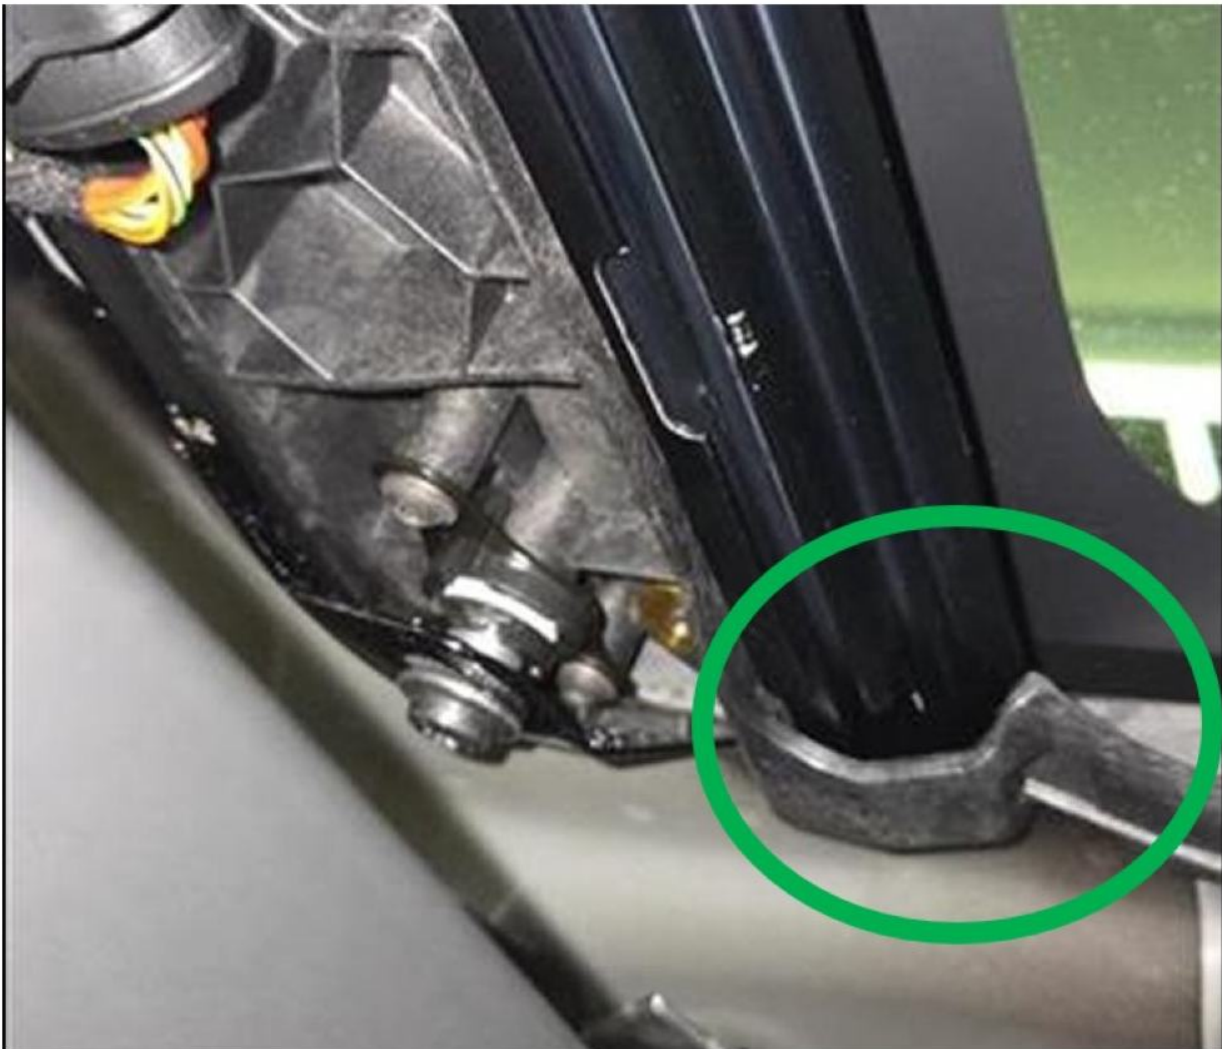
- Noise reproducible during road test and by manual manipulation of the rear sunroof rail.
- Noise traced with the headlining lowered.
- Noise source identified as contact between a metal sunroof guide rail and the plastic sunroof frame.
- Lubrication was ineffective.

The panorama sliding sunroof assembly consists of metal guide rails fixed and bonded to a plastic structural frame. Under certain operating conditions (body flex, uneven road input, thermal contraction/expansion), micromovement may occur at localised contact points. Where contact exists, a creaking noise can be generated. This concern is often more noticeable in cold conditions.

**Figure 1.** *Rear sunroof rail, overview of suspected contact area*

4. With the headlining lowered, inspect the interface between:

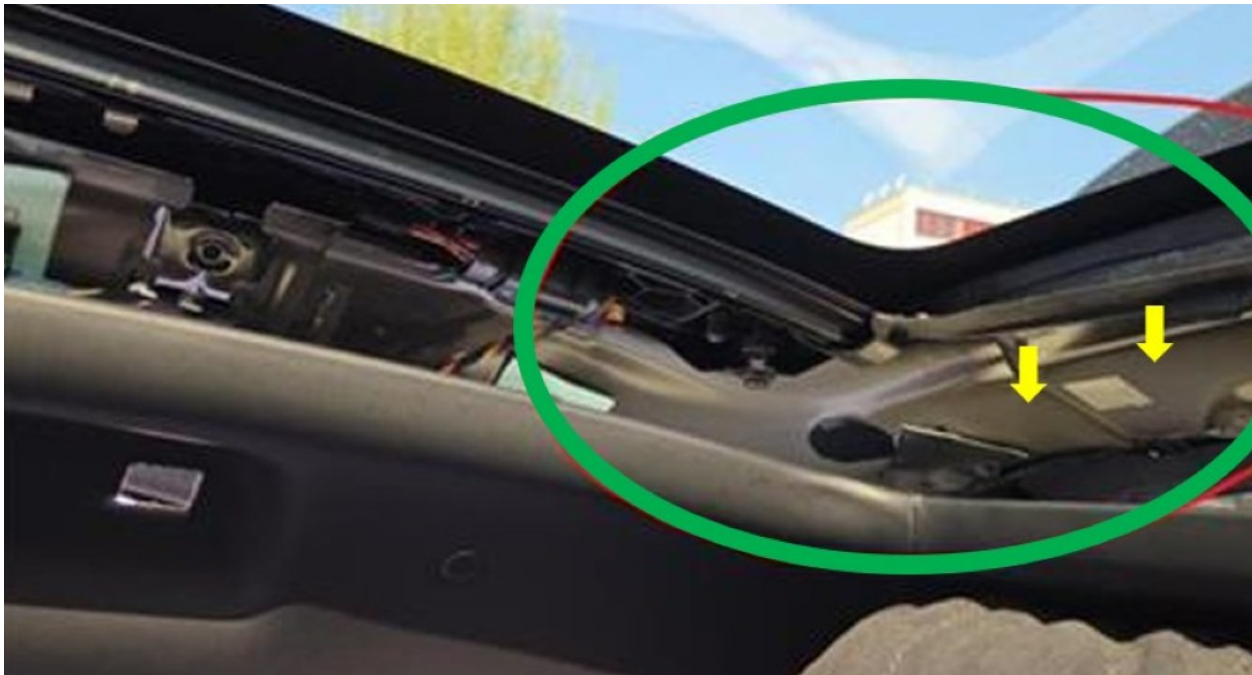
**Figure 2.** *Localised pressure application (arrow direction shown)*

6. Apply localised, controlled pressure to the plastic frame, as indicated by the directional arrows in Figure 2, to slightly disengage it from the metal guide rail while preventing deformation.

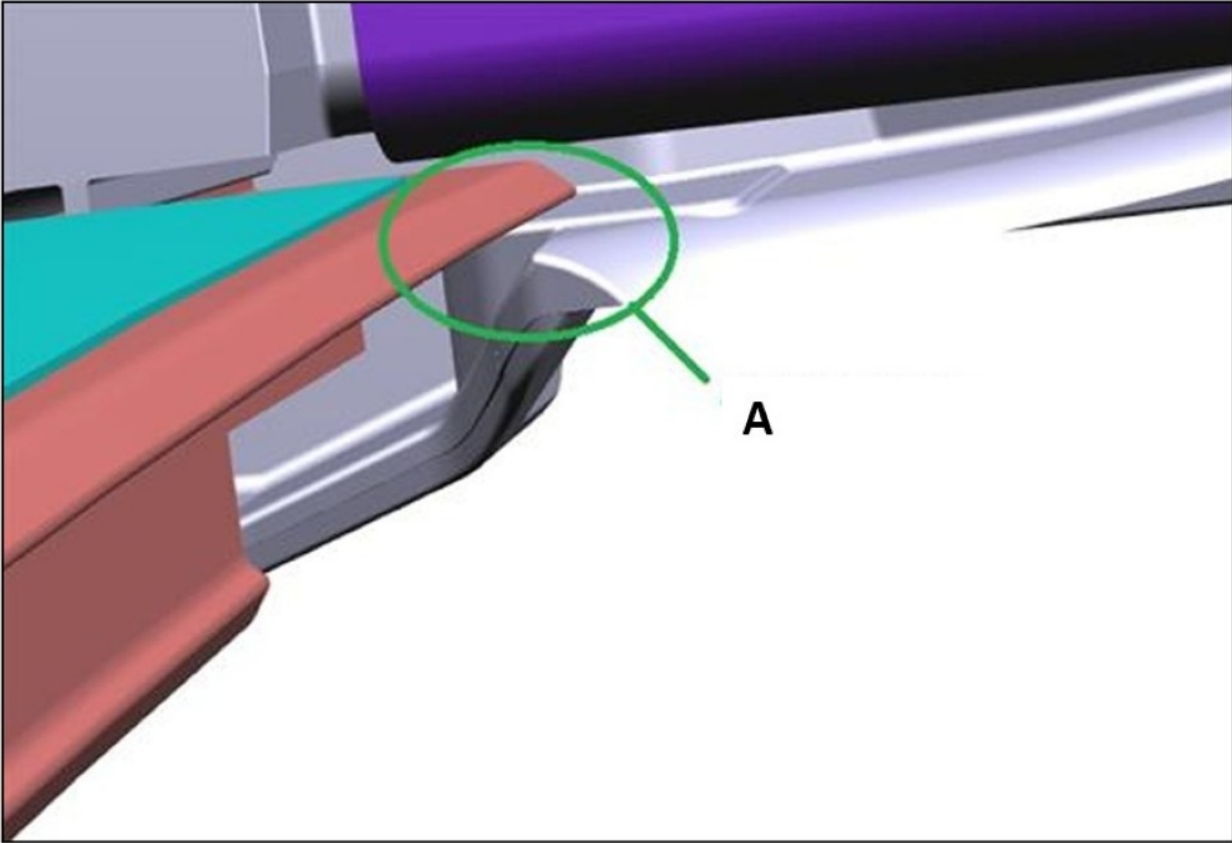
**Figure 3.** Point A: Anti creak tape application location

7. Insert anti creak felt tape between the contacting surfaces only at the identified contact point (Point -A- in figure 3).

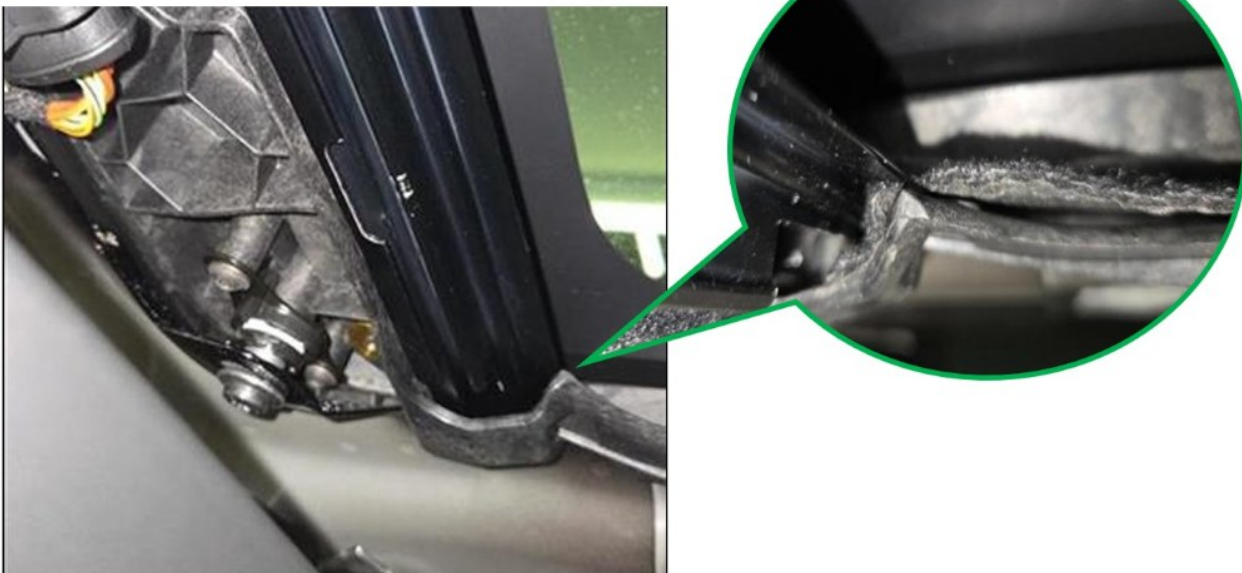
**Tape Application Location:** Metal to plastic interface shown in Figures 4 below with anti-creak tape applied.

**Figure 4.** Anti creak tape applied

Ensure the anti creak tape is applied in a manner that does not restrict rail movement, is not overpacked, and remains correctly seated once pressure is released.
