<b>Topic</b>	Software Update   Window Short Drop Deletion   Continental GT/GTC   26MY (SC26 /08)
<b>Market area</b>	United States E05 Bentley USA and rest America (6E05)
<b>Brand</b>	Bentley
<b>Transaction No.</b>	2081624/1
<b>Campaign number</b>	ED87
<b>Note</b>	
<b>Type</b>	
<b>US code</b>

Software Update | Window Short Drop Deletion | Continental GT/GTC | 26MY  
(SC26/08)

Release date: May 19,  
2026

# Retailer Glass Measurement Procedure for GT BY634

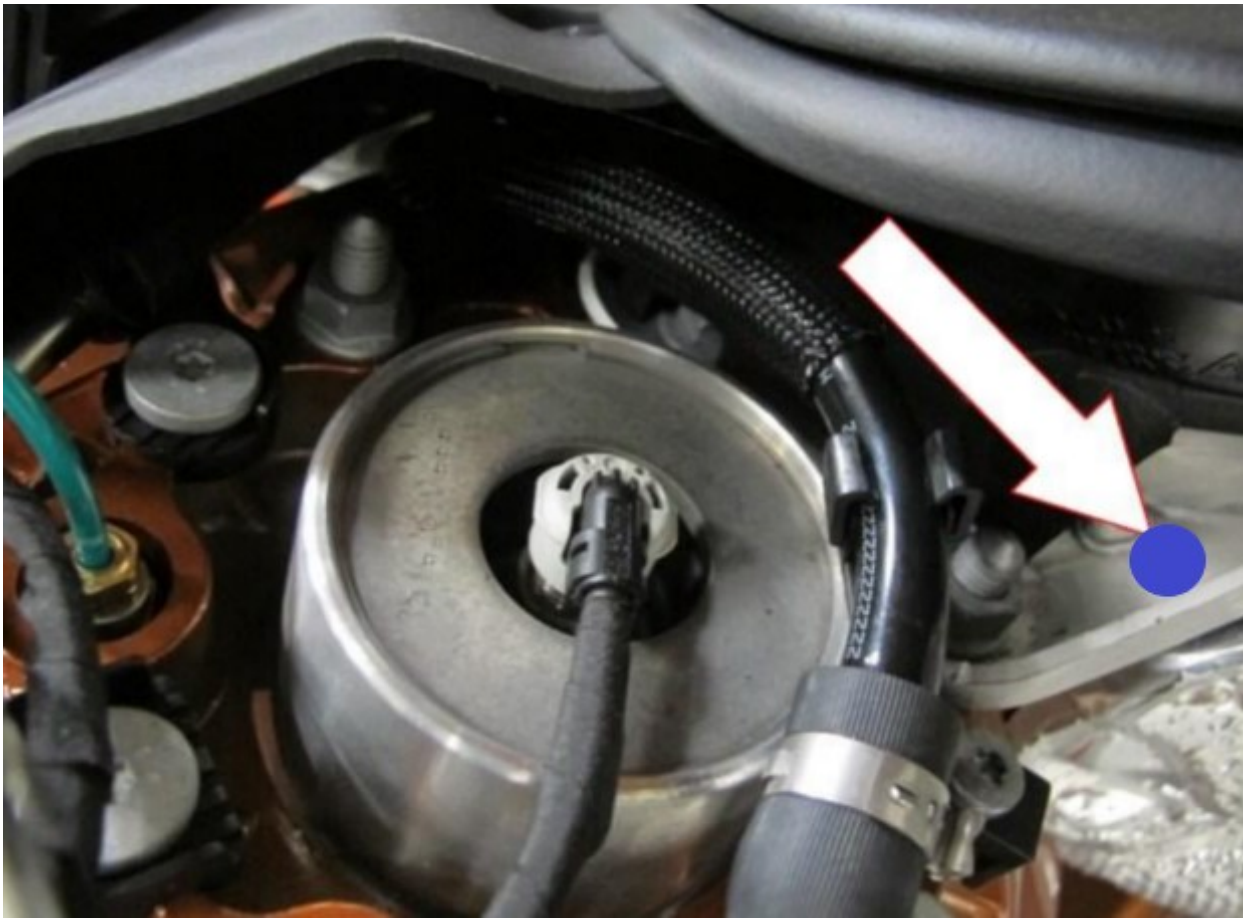
Blue paint completion mark on the engine partition brace.

6) Referring to the Identification section - Apply a blue paint completion mark on the engine partition brace.

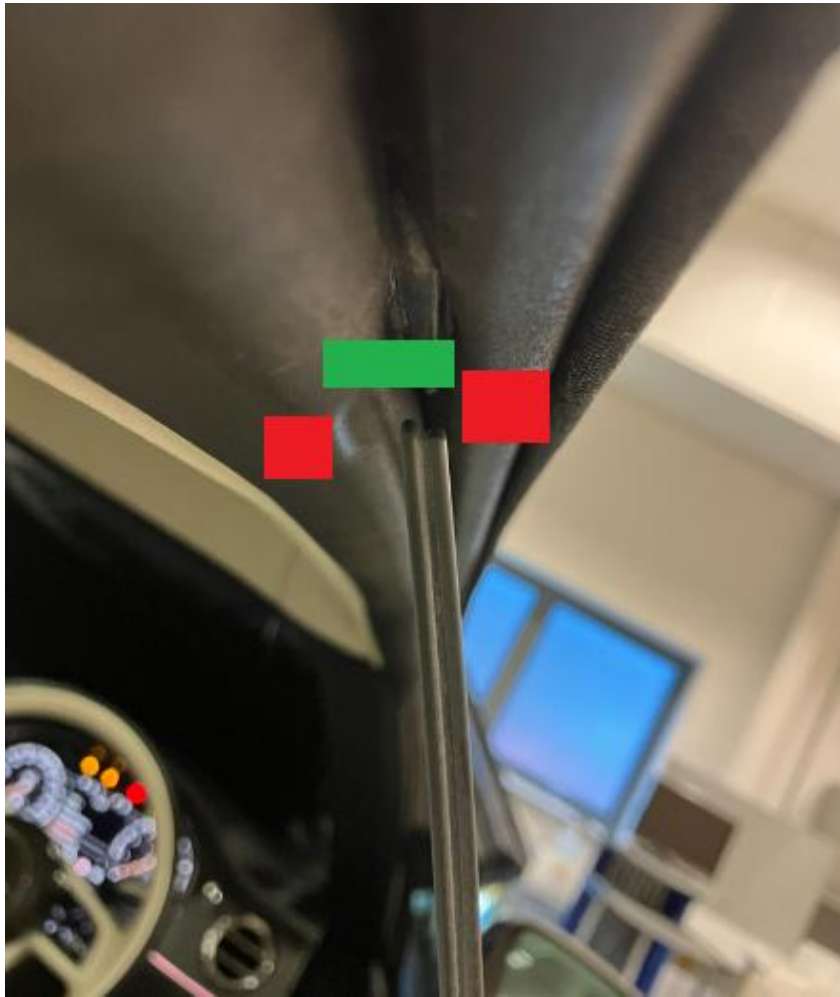
Front Window example showing correct operation

Windows should enter cant rail seal smoothly, making contact with green area.

For the front door, poor door profile point is a major contributing factor here and should be checked/adjusted if window found to be entering seal incorrectly.

If this is not correct, it will cause the window to bounce back causing a loss of basic settings.

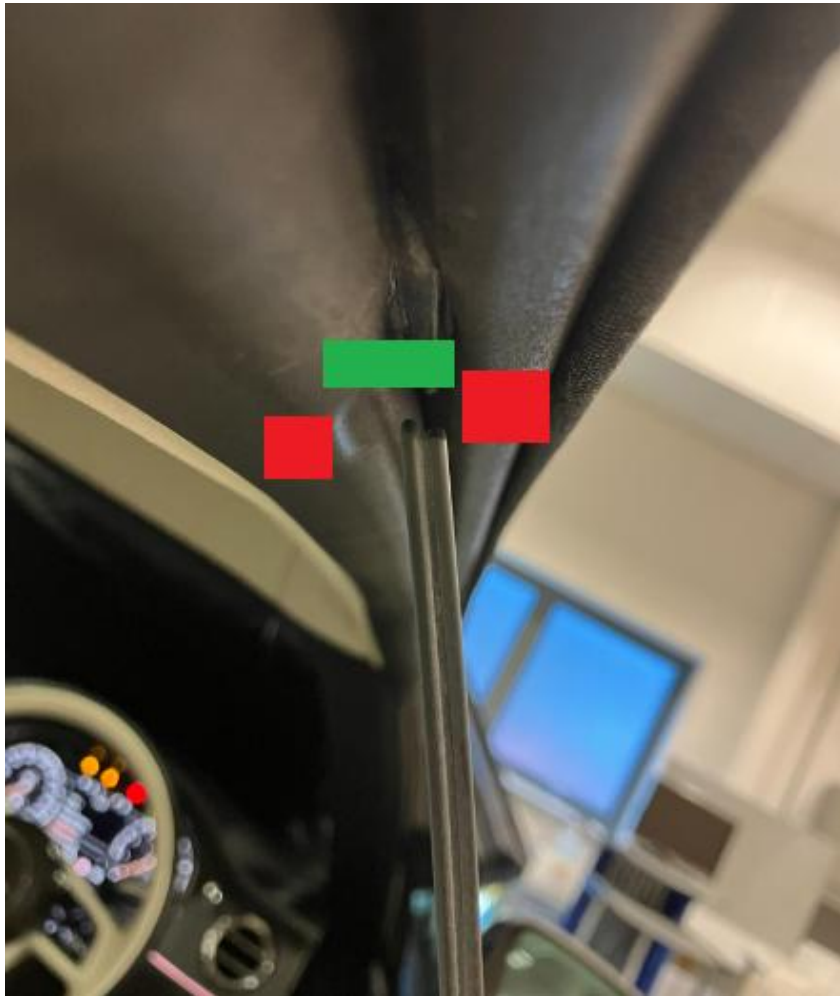
Front Window example showing correct operation

Windows should enter cant rail seal smoothly, making contact with green area.

For the front door, poor door profile point is a major contributing factor here and should be checked/adjusted if window found to be entering seal incorrectly.

If this is not correct, it will cause the window to bounce back causing a loss of basic settings.
