## Technical product information

Topic	Window Drop Glass Operation   Continental GT/GTC   25-26MY
Market area	Bentley: worldwide (2WBE),China 796 VW Import Comp. Ltd (Vico), Beijing (6796)
Brand	Bentley
Transaction No.	2080372/2
Level	EH
Status	Released for publishing
Release date	May 19 2026

Window Drop Glass Operation | Continental GT/GTC | 25-26MY

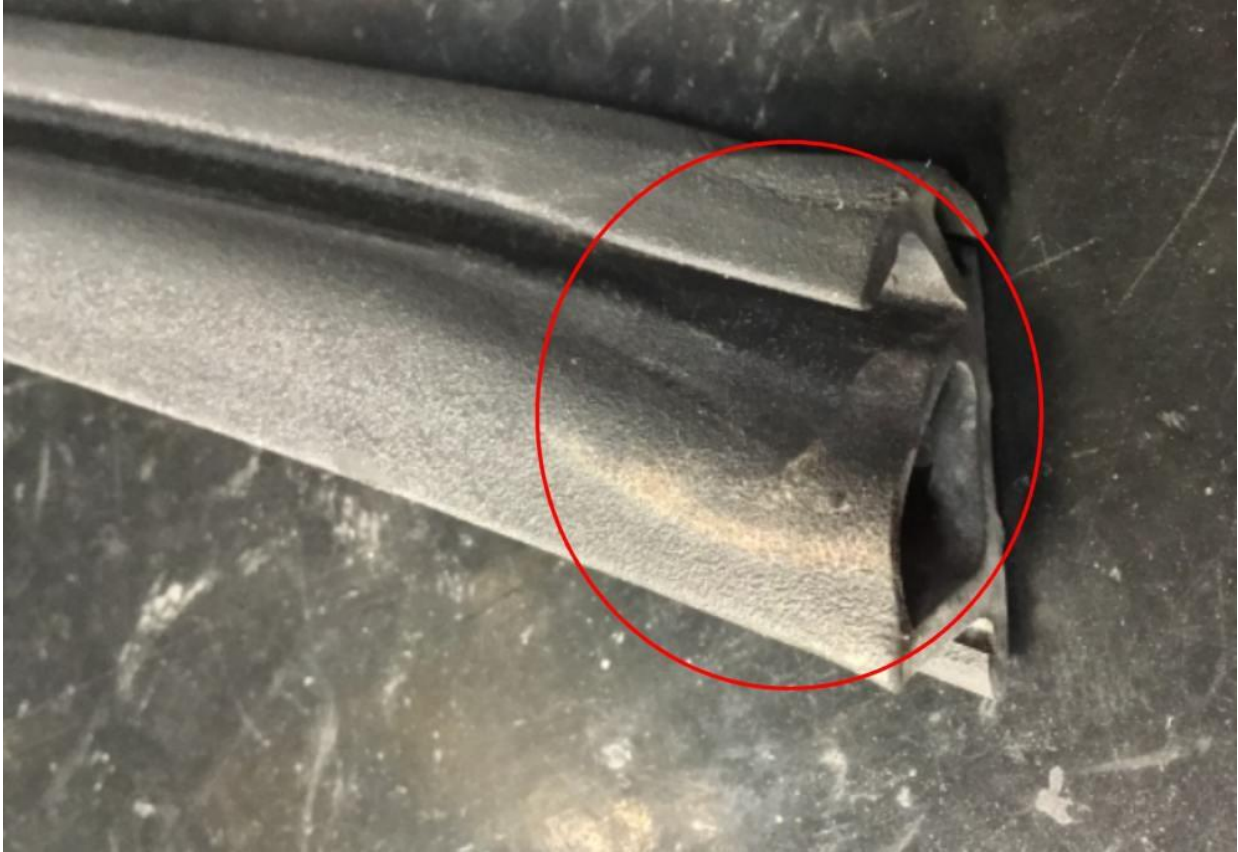
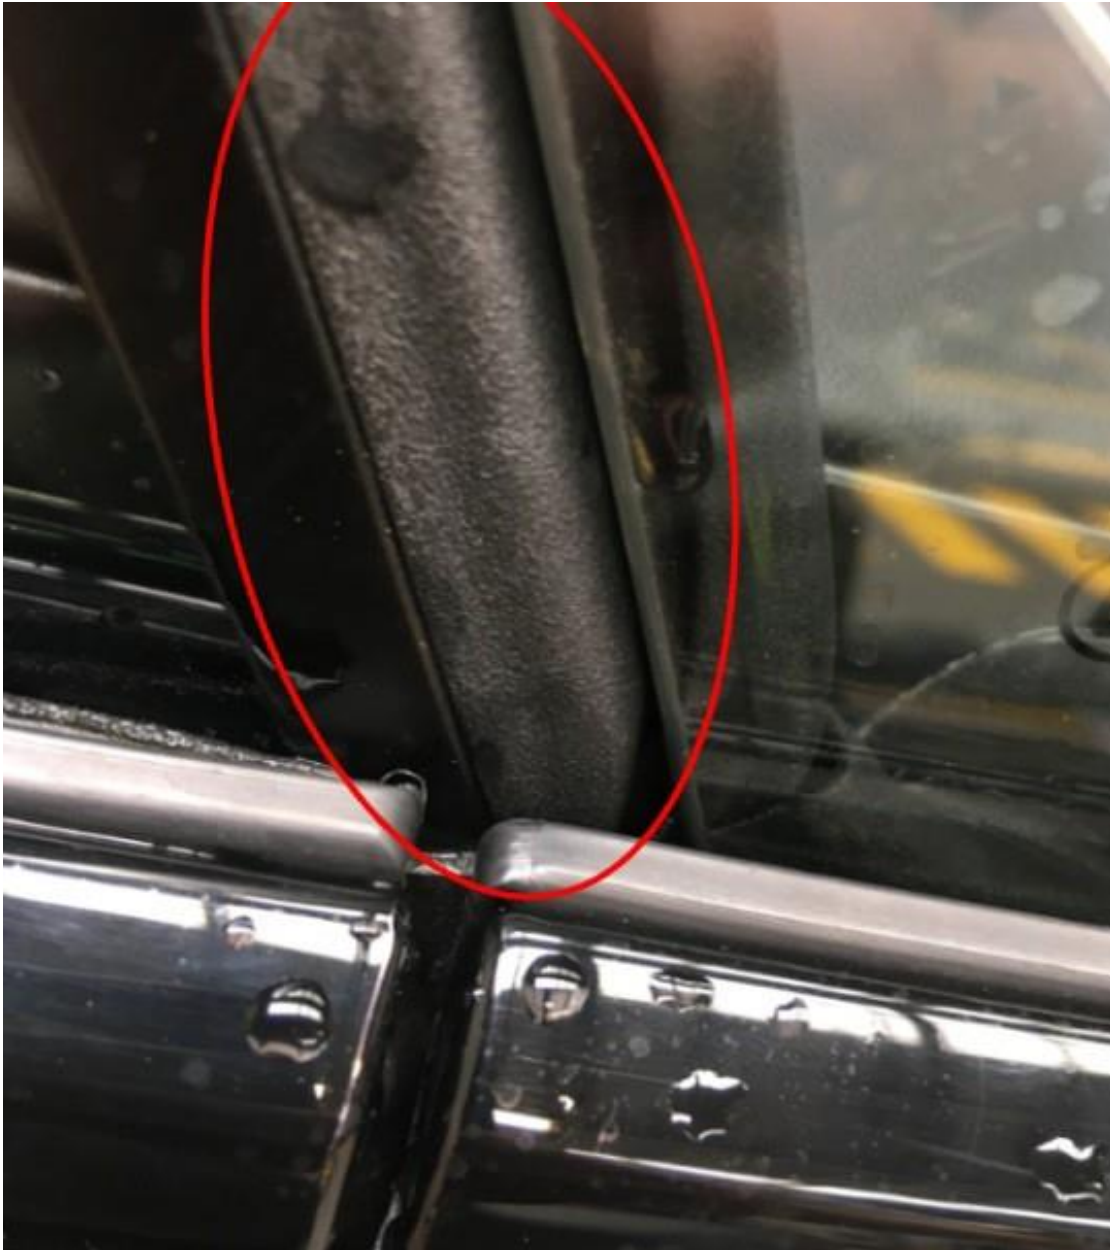
Figure 1

- Damage
- Splits
- Tears
- Misalignment

- Incorrectly fitted / located
- Drop glass seal deformation (see Figures 1 and 2 as examples)

NOTE: Any issues found with the window seals must be rectified before conducting the remaining steps

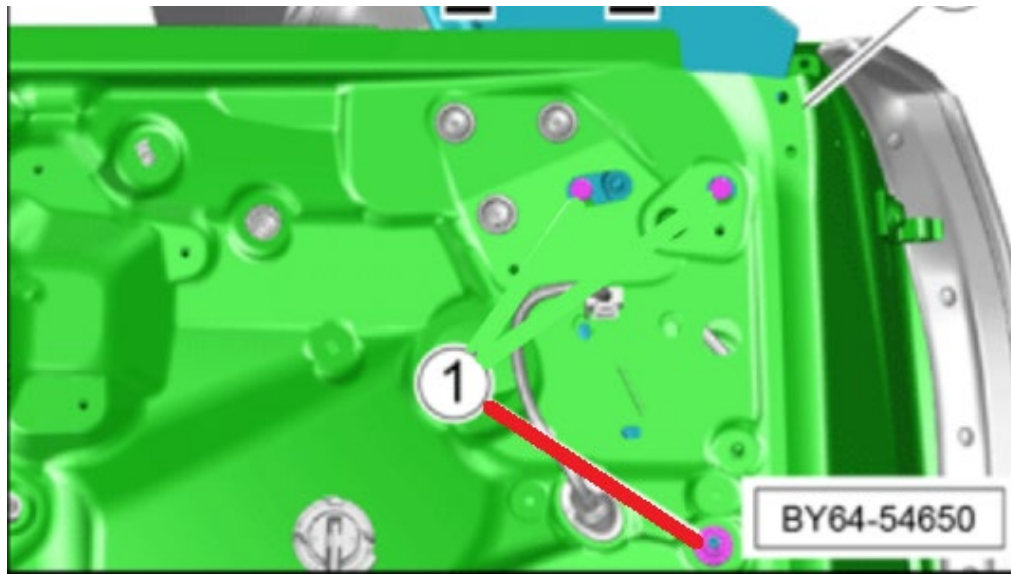
*Figure 1. Image for reference, glass does not require removal from vehicle*

In instances of multiple window drop concerns it has been found that to achieve the glass set specification, some adjusters are being adjusted out of specification.

In some cases, since not all adjusters are visible, there is a possibility that the adjusters can be set to their maximum inboard/outboard and induce excess tension in the regulators and affect the angle the windows enter the seals. There is free play built into the front and rear regulators, therefore as the windows are being held in place by the cant rail/convertible roof seals when closed, this may not be apparent when measuring. However, these extreme adjustments can cause issues with how the windows enter the cant rail/convertible roof seals or how the front and rear glasses interlock with each other, in some cases this can cause the seals to pinch and cause an anti-trap condition leading to window reversal.

The measurement between the bottom of the mounting washer and division bar frame, is 12.5mm.

1. loosen the lock nut.
2. Screw the adjuster fully clockwise until it bottoms out on the frame.
3. Unscrew the adjuster counterclockwise by four complete turns.
4. Resecure the lock nut.

Finally, set the height and profile to the TPI specification before proceeding to the next step.

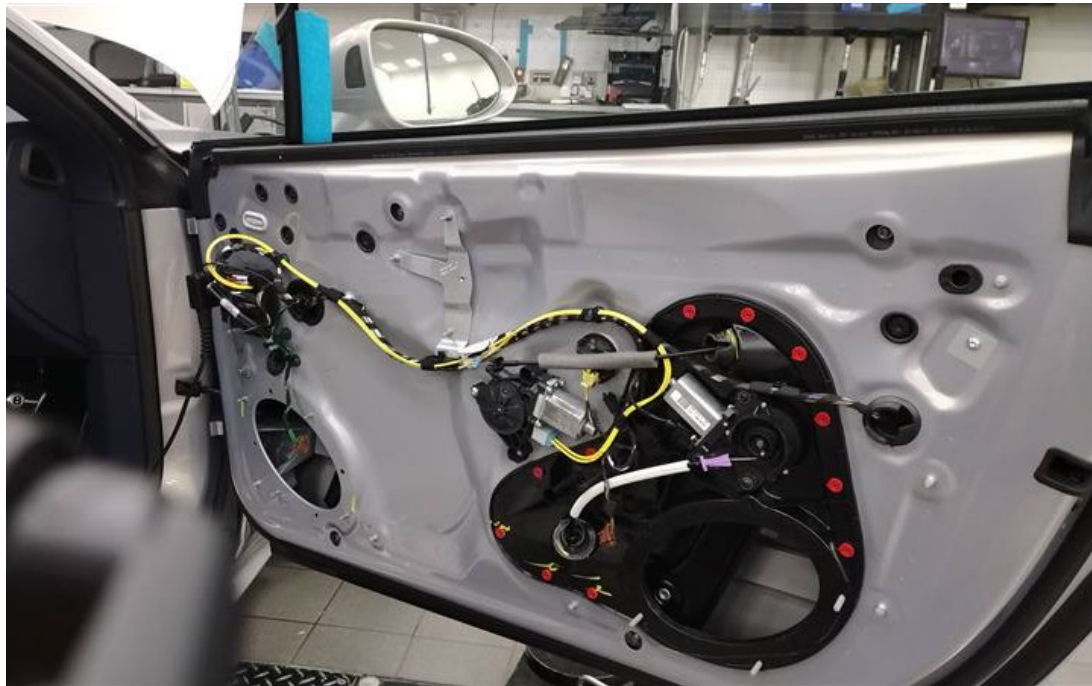
*Figure 8*

After completing the regulator reset procedure, measure the diameter of the motor-to-door ECU feed wires at the motor connector.

If the wires are 1.5mm diameter, carry out the replacement of the original motor-to-door ECU feed wires (yellow in the photograph) with the 2.5mm diameter new wires (part number: 000 979 242 E).

Refer to the information in ElsaPro Repair Group 97 Wiring harness repairs
