# Technical Service Bulletin

<b>Topic</b>	Front Axle Drive Shaft Thread Length Check (Service Inspection Instruction)   Continental GT /GTC/Flying Spur
<b>Market area</b>	United States E05 Bentley USA and rest America (6E05)
<b>Brand</b>	Bentley
<b>Transaction No.</b>	2082062/1
<b>Level</b>	EH
<b>Status</b>	Released for publishing
<b>Release date</b>	May 20, 2026

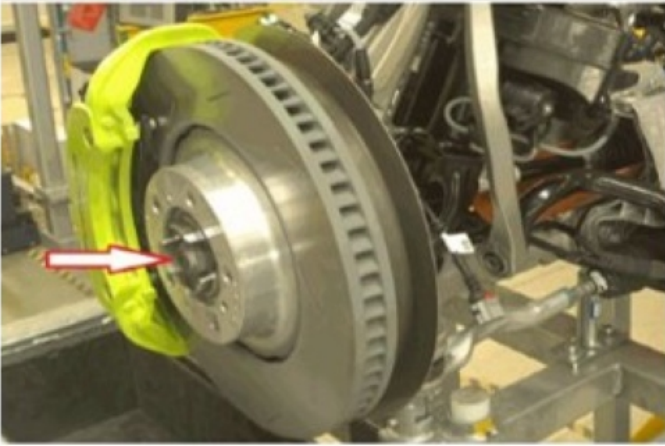
1. With the front road wheel removed, visually inspect the front axle drive shaft at the wheel hub.
2. Confirm whether the drive shaft thread protrudes beyond the wheel hub nut by several visible threads (at least 3 threads should be visible).
3. Refer to the images below for an OK/Not OK condition.

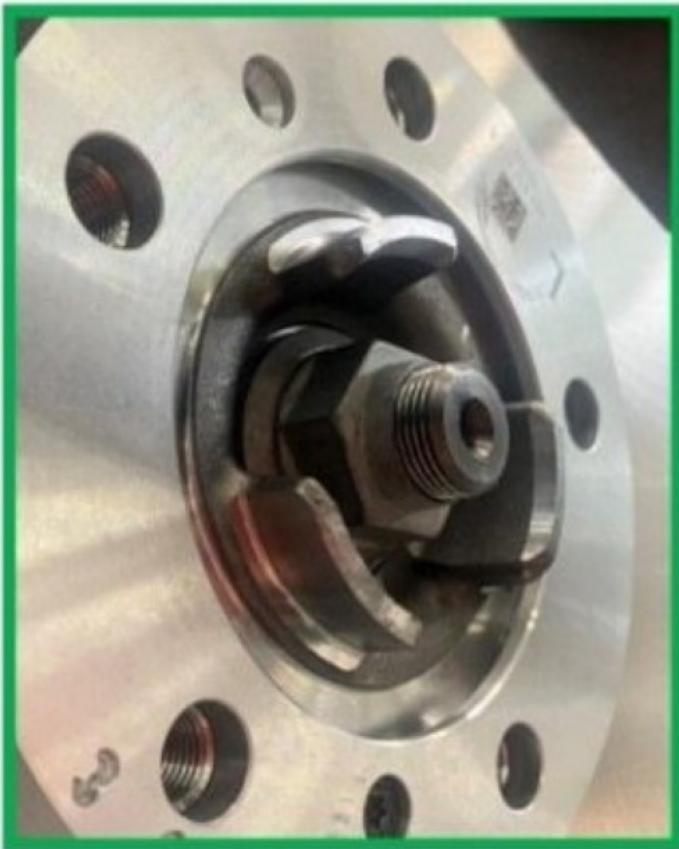
**# Acceptable condition: Several complete threads visibly protruding beyond the nut.**

If the inspection confirms an OK vehicle condition, rebuild the vehicle to specification. Raise an Info only DISS query, including clear photographic evidence of both front axle drive shafts to support the inspection result.

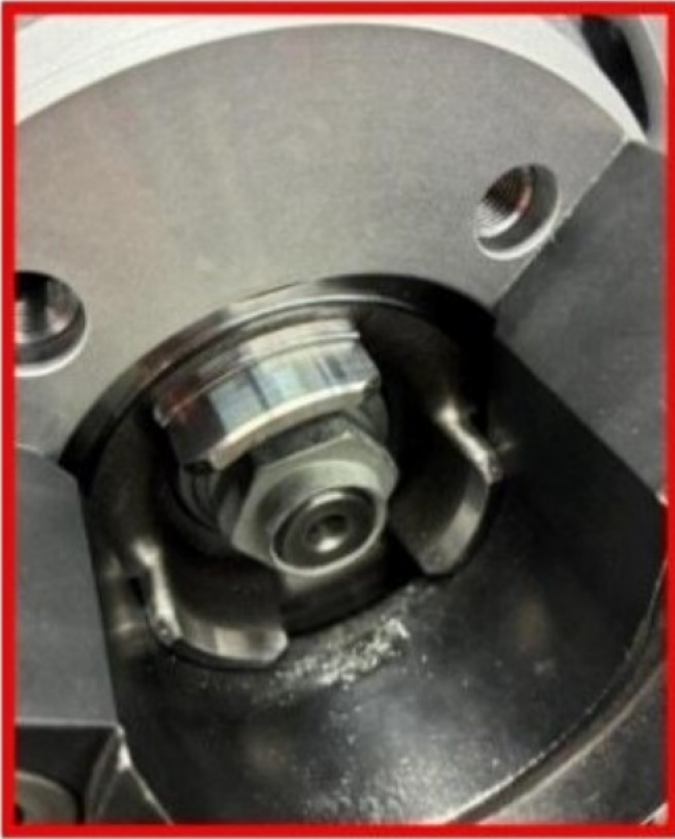
# Unacceptable condition: Thread flush with nut face or recessed.

If the inspection confirms a NOT OK vehicle condition, do not reassemble or carry out any further work. A valid full Technical DISS ticket must be raised, including clear photographic evidence of the drive shaft thread length condition, and no further action must be taken until guidance is received.
