Technical product information

Topic	Rattle / Creak from the dashboard demister panel
Market area	Bentley: worldwide (2WBE),China 796 VW Import Comp. Ltd (Vico), Beijing (6796)
Brand	Bentley
Transaction No.	2075693/4
Level	EH
Status	Released for publishing
Release date	May 21 2026

Continental GT / C and Flying Spur

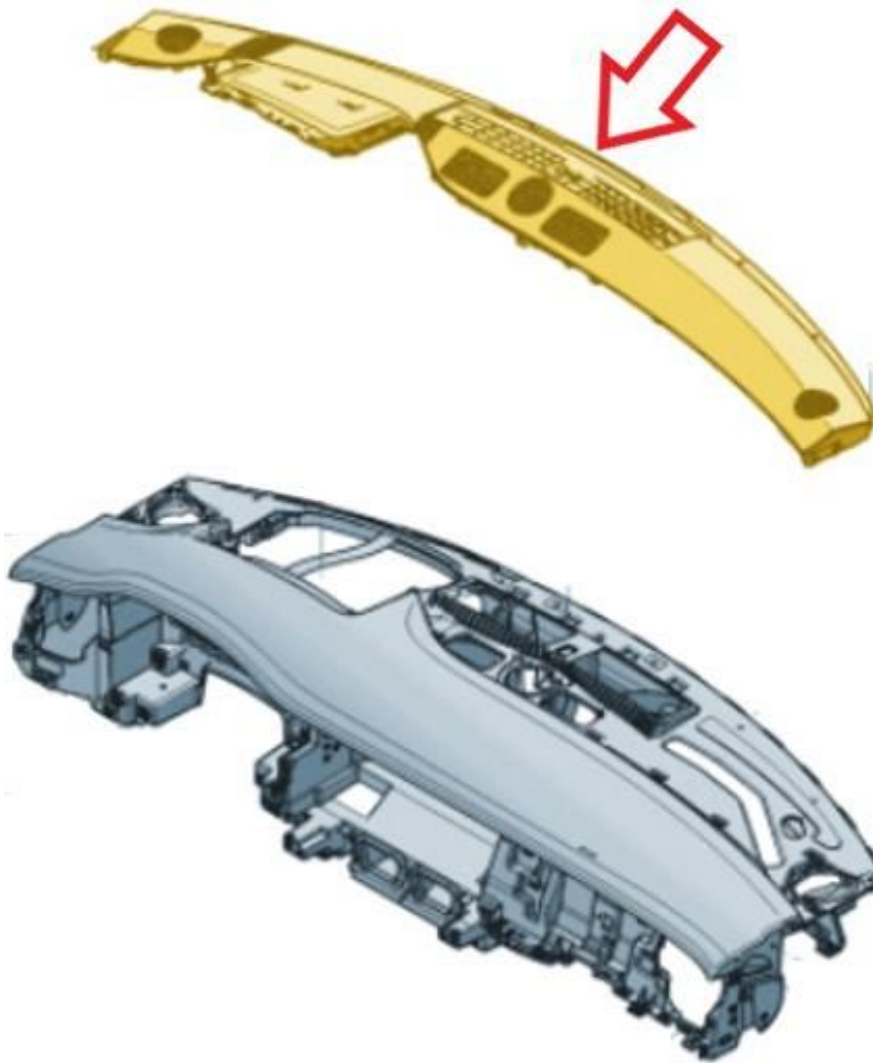
Figure 1

Rattle / Creaking noise from the dashboard demister panel (Figure 1)

In the event the issue is as described please refer to the Measure section
