Technical Service Bulletin

26-EM-012H

PALISADE (LX2)

SUBJECT: OIL LEAK – ENGINE OIL FILTER HOUSING SEAL REPLACEMENT
(WARRANTY EXTENSION Z15)

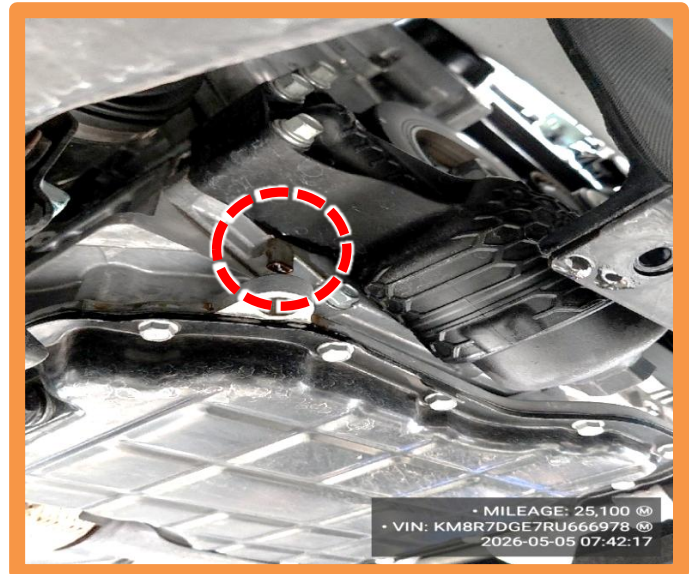
Using the STUI camera function, take a photo of the engine oil leak at the oil filter housing.

Upload the photo to STUI.

NOTE: If the STUI camera function is **NOT** used, write the last 6 digits of the VIN and date of repair on a piece of paper to include in the photo.

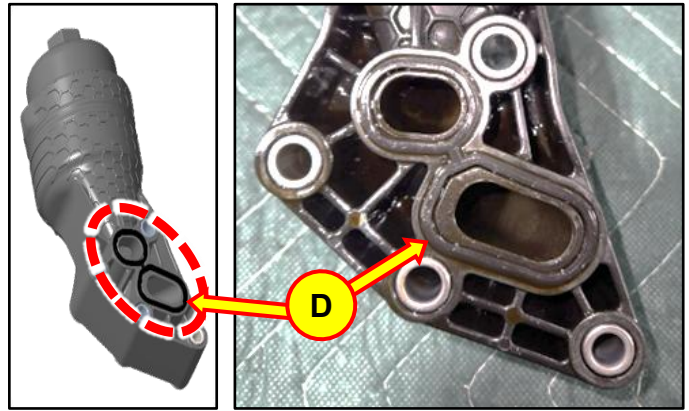
Description: Some Palisade (LX2) vehicles may exhibit engine oil leakage at the engine oil filter housing assembly due to deterioration of the housing seal.

6. Remove the oil filter housing seal (D).

7. Thoroughly clean the oil filter housing and mating surfaces, then install the new oil filter housing seal.
8. Reinstall all parts in the reverse order of the removal process.
9. Fill the engine crankcase with approximately **6 quarts** of engine oil.
