# Service Bulletin

Bulletin No.: PIP6031E

**Subject: CVT Transmission Leaks From Case Half**

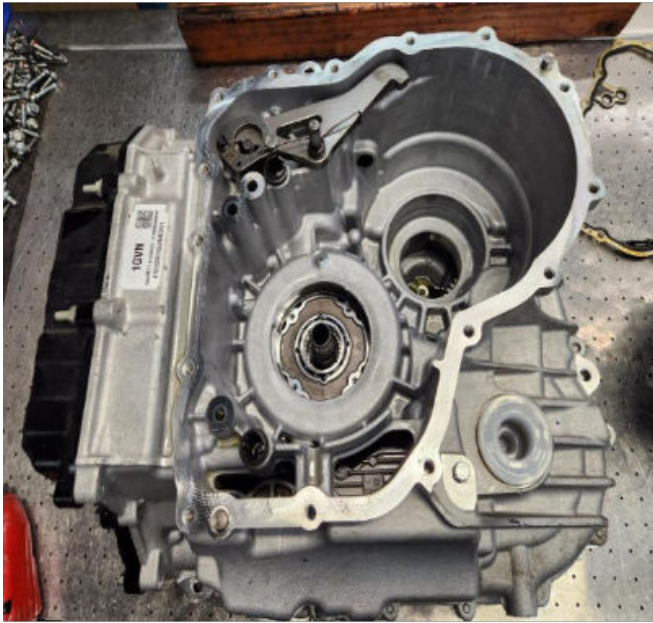
6750270

Machining Imperfection as seen below can be repaired by block sanding the case with either 400 or 600 grit sandpaper then replacing the gasket.

**Note:** When sanding the case attention must be paid to prevent taking off too much material, all that needs to be done is to remove the machining damage to the case.
