Technical Journal

Technical Journal Title Panoramic sunroof, sealing strip have a gap		Ref. No. TJ 35503.4.0	
Issuer (Dept.) Technical Service		Issue Date 4/24/26	Status Date 4/29/26
Car Market United States and Canada	Partner 3 US 7510 Volvo Car USA	Function Group 8363	
Function Description Sealing		Page Page 1 of 3

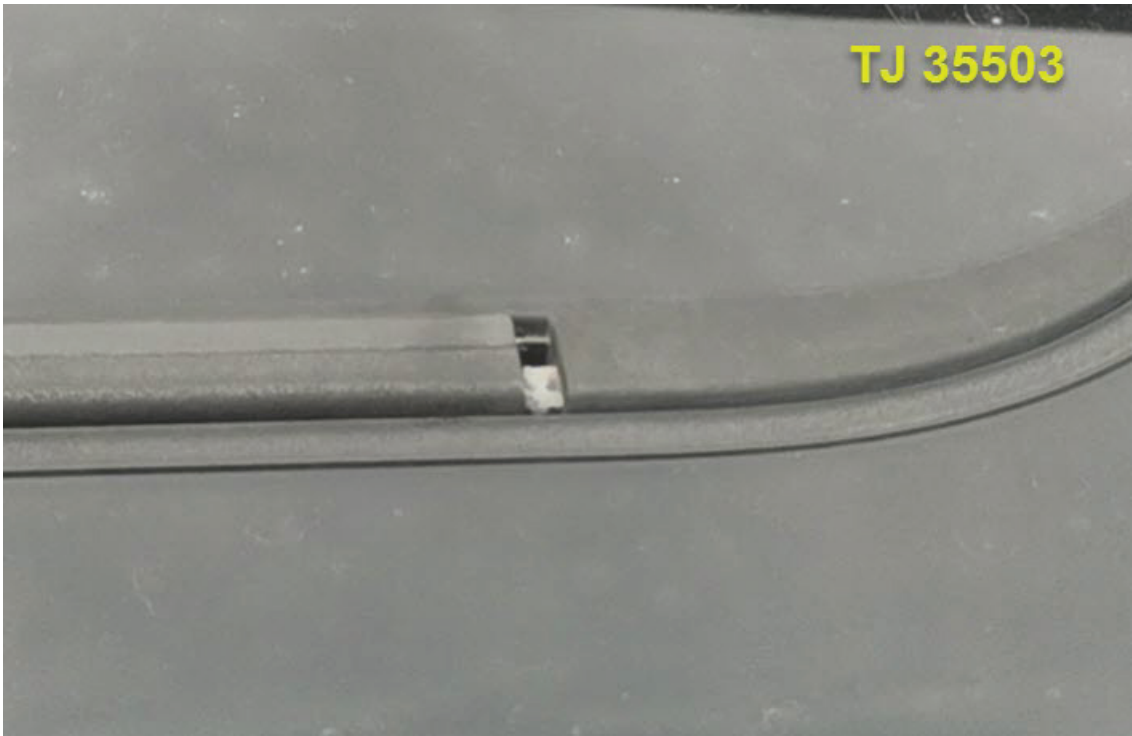
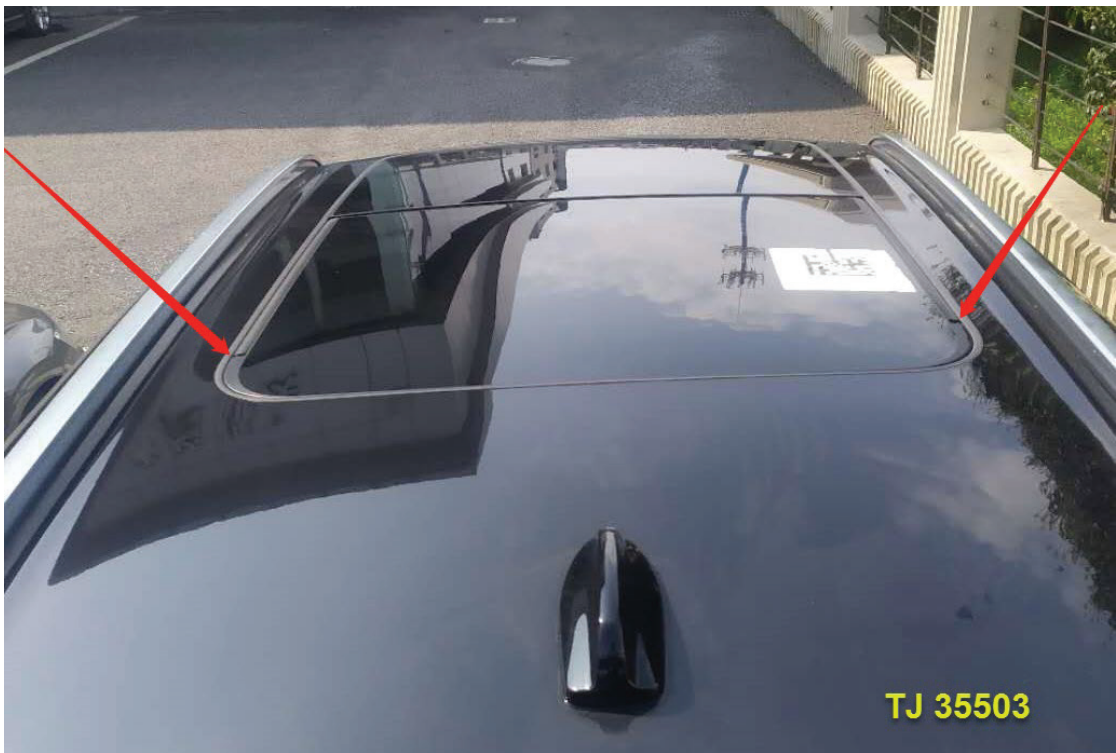
If the customer complains that the sealing strip in rear end of the panoramic sunroof is too short, or if the short sealing strip causes water leaks into the car, please follow advice under Service.

In normal conditions, even if there is a gap in the sealing trim, incoming rain water will be evacuated through the sunroof drainage hoses.

In rare conditions, an extensive gap may lead to water leak from the sunroof frame but only if extensive amount of dirt and debris have accumulated in the gutter, or if any of the water drainage hoses is blocked due to dirt and debris. If the customer has reported water leakage in combination of a large gap in the sealing strip, please replace the sealing strip but also check the sunroof drainage function and clean if necessary. If any of the drainage hoses is found deformed (kinked), then replace that hose as well.

Replace the sealing strip and glue it in each end it according to the method in VIDA, search for VCC ID: VCC-508558-1 or VST Op.No 83684-2

Glue PN: Würth catalogue PN 0893092

*Sealing strip PN: 31395509
