# Service Bulletin

Bulletin No.: PIT6477C

**Subject: Unable to Perform GDS2 Automated Bleed After Master Cylinder Replacement**

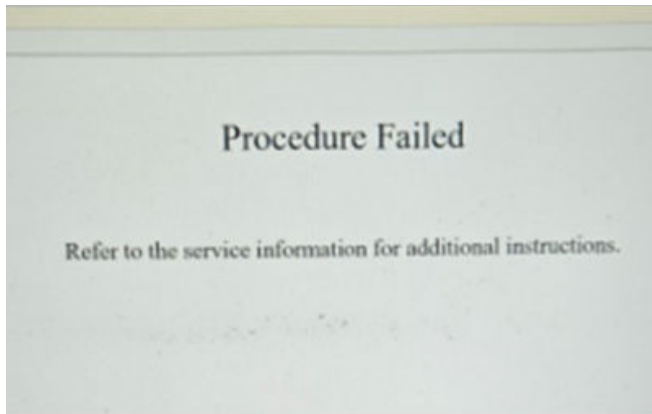
7058016

<b>Involved Region or Country</b>	North America
<b>Condition</b>	Some Technicians may notice that they get an error screen when trying to perform the automated bleed after master cylinder replacement, (See Error Screen Below).
<b>Cause</b>	Software Anomaly with GDS2 Software.

An updated version of GDS2 has been released to address this issue. Please launch Techline Connect (TLC) and verify that GDS2 is updated to GM Global version v2026.05.31 or later.

When performing the GDS2 Auto Brake Bleed procedure, you will now see two options: "Automated Brake Bleed" and "Modified Automated Brake Bleed."

Begin by selecting "Automated Brake Bleed." If the procedure completes successfully, no further action is required.

If the "Automated Brake Bleed" procedure does not complete successfully, proceed with "Modified Automated Brake Bleed," which incorporates the updated fix.
