Subject: N262560680 - Service Update
Transmission Control Body Missing Bolt

Models: 2026 Chevrolet Silverado 2500 HD/3500 HD
2026 GMC Sierra 2500 HD/3500 HD

N262560680 Transmission Control Body Missing Bolt

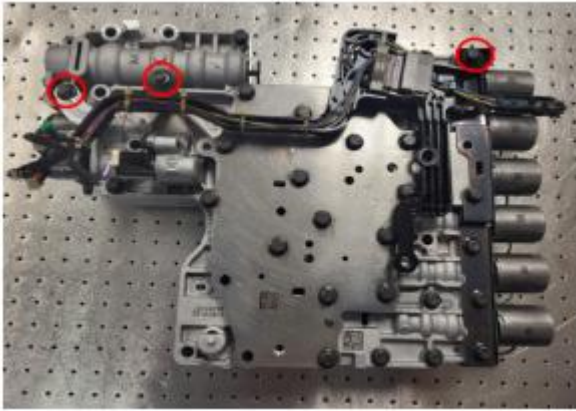
6985470

Note: Please note the location of the harness retaining bolts. The middle bolt is longer than the outside bolts.

2. Remove the three bolts circled above retaining the wiring harness and relocate it out of the way.

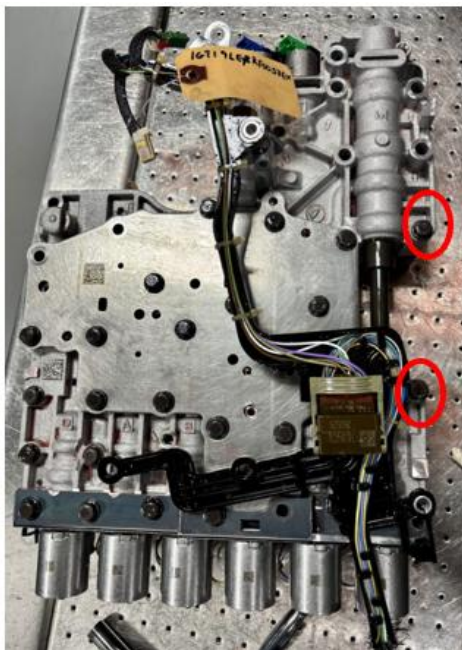
7155314

Condition	Certain vehicles listed above may have a condition in which the bolts for the transmission control valve body may be loose or missing.
Correction	Dealers will retorque or replace the suspect valve body bolts.

3. Verify the two valve body bolts circled above are torqued to **9 NM (80 in-lbs)**. Install new bolt(s) if missing.
4. Reposition the wiring harness and torque the three harness bolts to **9 NM (80 in-lbs)**.
5. Install a NEW transmission filter and pump seal before reinstalling the transmission fluid pan. Refer to *Automatic Transmission Fluid, Fluid Pan and/or Filter Replacement* in SI.
6. Fill the transmission to the proper level with NEW transmission fluid. Refer to *Transmission Fluid Fill Procedure* in SI.
