TECHNICAL SERVICE BULLETIN

Clunk Noise While Turning At Low Speeds

26-2264
10 June 2026

Ford 2021-2026 F-150	Built on or before 13-Jan-2026 Equipped with steel rear leaf springs
--------------------------------	-------------------------------------------------------------------------

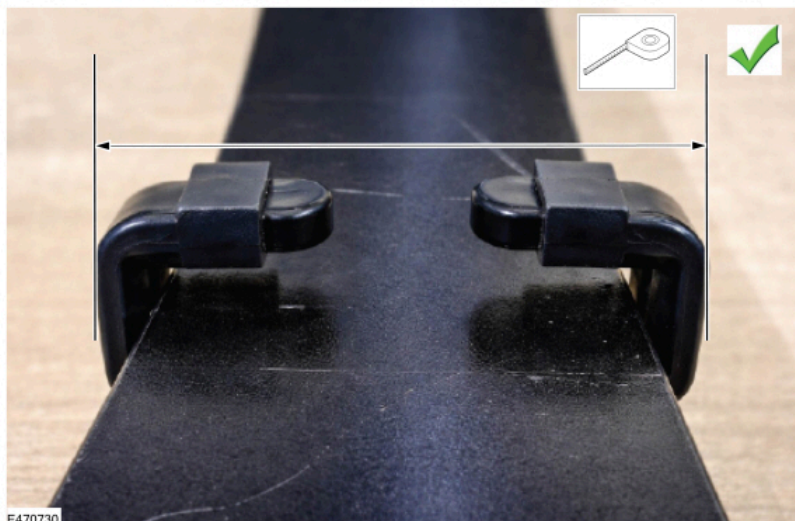
Figure 1

1. Inspect the rear leaf spring clinch clips. The width of the clip should be no greater than 103 mm (4 in.), refer to Figure 1. Clip to leaf gap should be a minimum of 3 mm (0.12 in.), refer to Figure 2. Are the clinch clips within specification?

Item	Description
Clinch clip width	103 mm (4 in.)

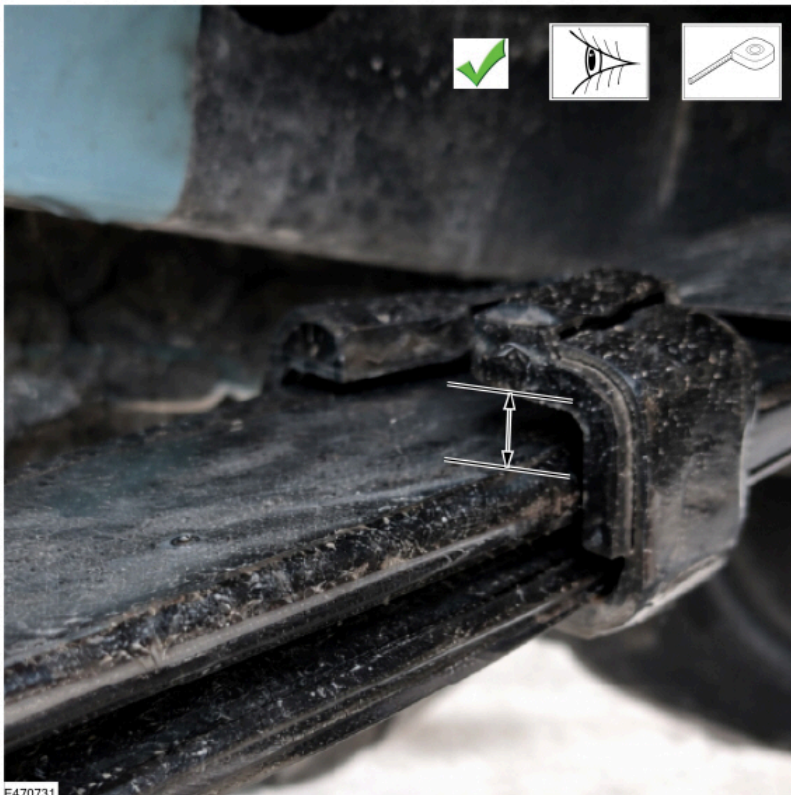
Figure 2

Item	Description
Clip to leaf gap	3 mm (0.12 in.)

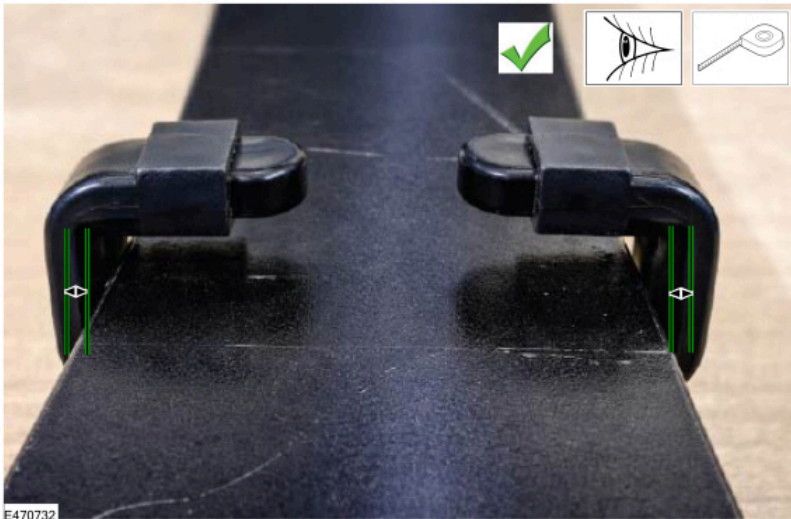
Figure 3

Item	Description
Leaf to clip clearance	2 mm (0.08 in)

2. Use a C-clamp to compress the affected clinch clip into position. When compressing the clinch clip into position, make sure the clips are clear of the leaf by 2 mm (0.08 in.) minimum on both sides as shown in Figure 3.

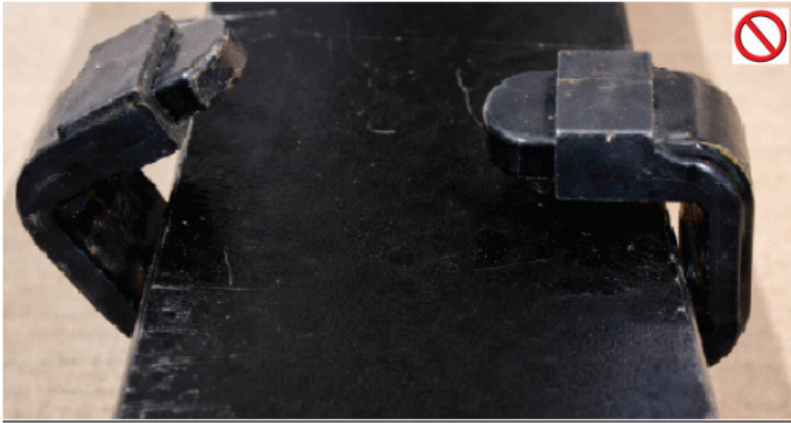
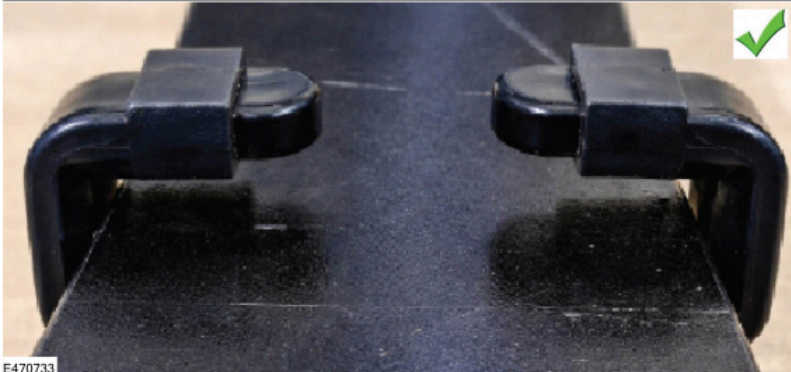
Figure 4 - Upper illustration shows an example of a clip out of position, lower illustration shows the clip compressed back in position
