## Throttle lift-off clunking noises at drive shafts of rear axle

| Topic number | LI35.30-P-058566 |
| Function group | 35.30 - Final drive, drive shafts |
| Validity | Mercedes Benz cars and SUVs as of manufacture year 1996 |

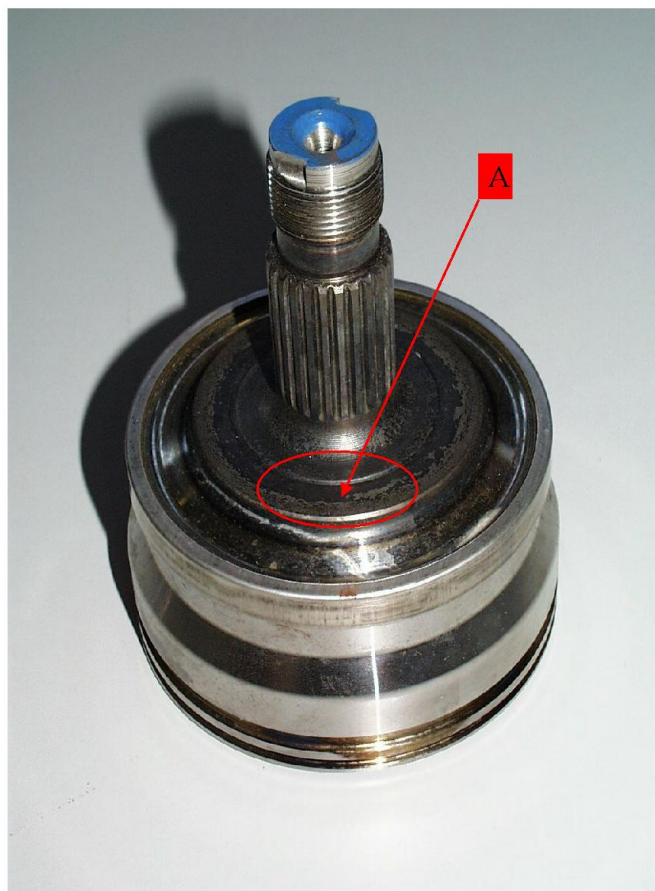
| Attachments | |
|---|---|
| <a href="#">Gelenkgehäuse aussen vor.jpg</a> | Before coating with Molykote paint |

If the complaint is eliminated by experimentally loosening the outboard collar nut (by 1 turn), the problem is due to cracking of the microweld between the wheel bearing inner race and the joint housing of the side shaft.

1. Remove side shafts
2. Clean contact surface A (see image file in attachment "Outer joint housing before") before coating with Molykote, using "spirit" (free of dust and grease)
3. Coat contact surface A (see image file in attachment "Outer joint housing after") with Molykote and leave to dry for "one hour" in removed condition
4. Reinstall side shafts

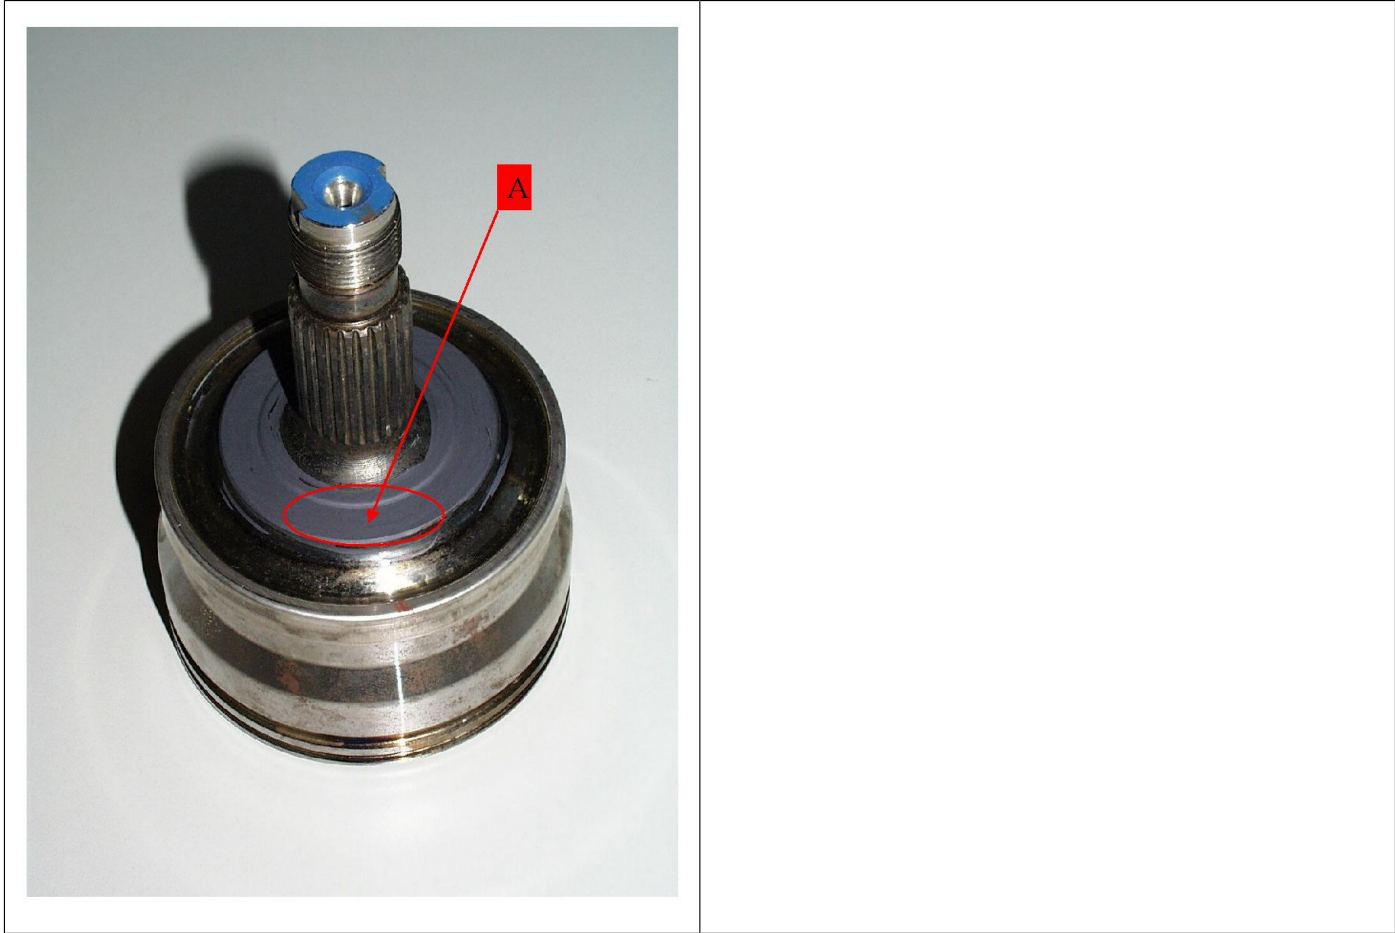
[Gelenkgehaeuse aussen nach.jpg](#)

After coating with Molykote paint
