2020-2021MY  
Niro EV (DE EV)

PI2603Y

## TECHNICAL SERVICE BULLETIN

## BSA REPLACEMENT (PI2603Y)

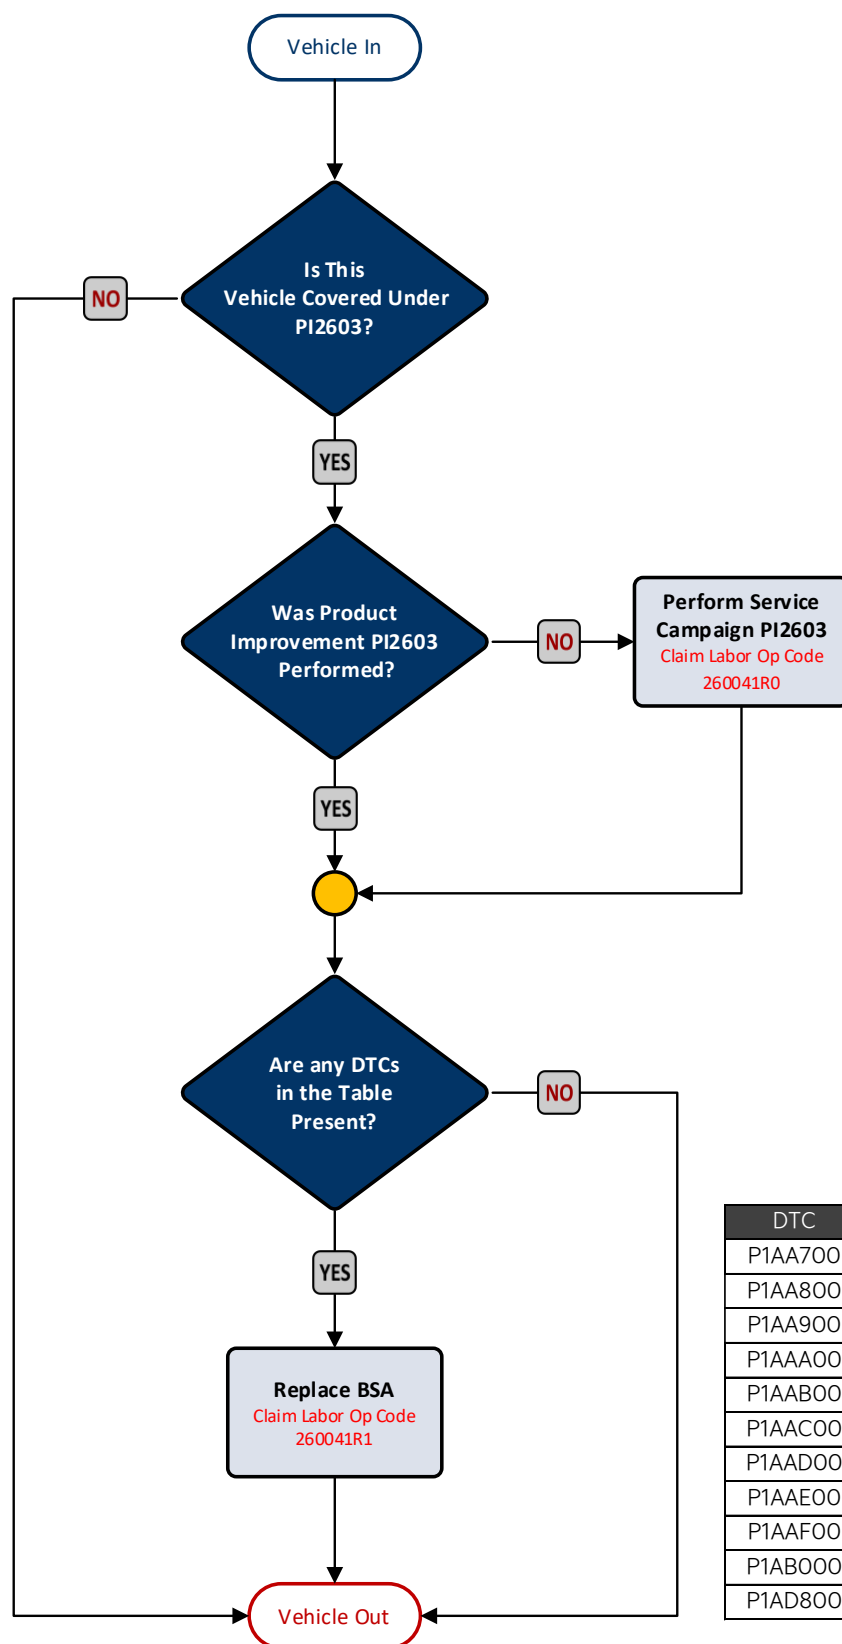
## Flowchart:

This bulletin provides information related to the Technical Service Bulletin previously published under PI2603, titled "BMS Battery Diagnostic Logic Improvement." If one or more of the Diagnostic Trouble Codes (DTCs) listed in the table below are present or stored after the Battery Management System (BMS) software upgrade has been performed per PI2603, follow the procedure outlined in this publication to replace the Battery System Assembly (BSA) on the applicable vehicle. Before conducting the procedure, verify that the vehicle has completed the BMS software upgrade and is included in the list of affected VINs.
