GENERAL MOTORS  
DCS 7536  
URGENT - DISTRIBUTE IMMEDIATELY

Subject: UPDATE: N262559000-01 - Service Update  
RESS Cell Balancing Battery Drain  
Revised Service Procedure & Population Expansion

Models: 2027 Chevrolet Bolt

## N262559000 RESS Cell Balancing Battery Drain

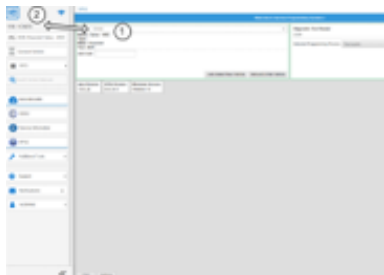
7001095

**IMPORTANT:** The service technician always needs to verify that the VIN displayed in the TLC left side drop down menu (1) and the top center window (2) match the VIN plate of the vehicle to be programmed prior to using Service Programming System 2 (SPS2) for programming or reprogramming a module.

1. Connect the vehicle to a 12-volt battery maintainer, as these vehicles may have a low state of charge on the high voltage battery.
2. Reprogram the K16: Battery Energy Control Module. Refer to *K16: Battery Energy Control Module* in SI. Carefully read the programming and setup document for further instruction.

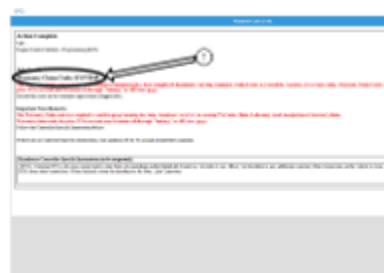
7001097

**Important:** To avoid warranty transaction rejections, you **MUST** record the warranty claim code provided on the Warranty Claim Code (WCC) screen shown above on the job card. Refer to callout 1 above for the location of the WCC on the screen.

3. Record SPS Warranty Claim Code on job card for warranty transaction submission. Refer to *25-NA-281 Information on SPS Warranty Claim Code Submission and Retrieval* in SI.
