**HYUNDAI**  
**Technical Service Bulletin**

| GROUP<br><b>BODY</b> | NUMBER<br><b>26-BD-007H</b> |
| DATE<br><b>JULY 2026</b> | MODEL(S)<br><b>SEE BELOW</b> |

**SUBJECT:** WIPER PARK POSITION MISALIGNMENT – WIPER MOTOR CRANK ARM NUT REPLACEMENT (WARRANTY EXTENSION Z08)

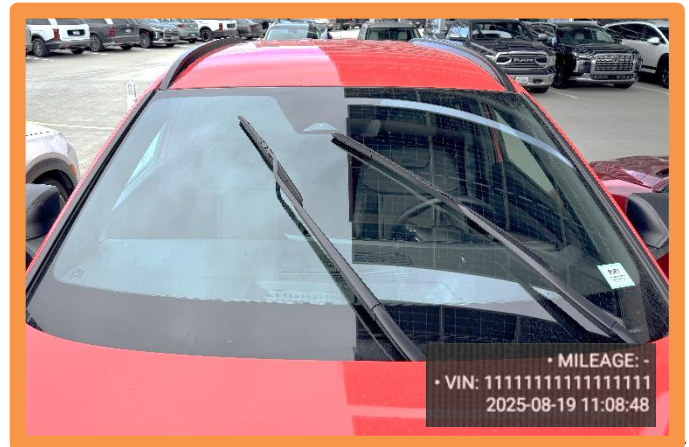
Using the STUI camera function, take a photo of the windshield wipers parking in the incorrect position on the windshield.
