| <b>HYUNDAI</b><br><b>Technical Service Bulletin</b> | GROUP<br><b>BODY</b> | NUMBER<br><b>26-BD-003H</b> |
| | DATE<br><b>JULY 2026</b> | MODEL(S)<br><b>SANTA CRUZ (NXT)</b> |
| <b>SUBJECT:</b> TONNEAU COVER INSPECTION & REPAIR GUIDE | | |

**This TSB supersedes 25-BD-011H-1 to update the “Tonneau Cover Repair” procedure by adding steps 4 – 6 on pages 10-11 for re-tensioning the tonneau cover (Tonneau Cover Repair).**

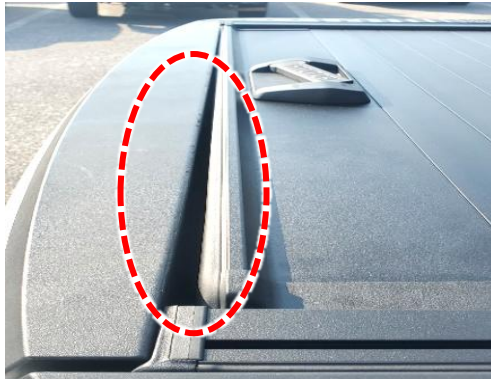
| Condition | QR Code/Link/Figure | | Remedy |
|---|---|---|---|
| V-Gap between cover and tailgate when closed and latched | | | |

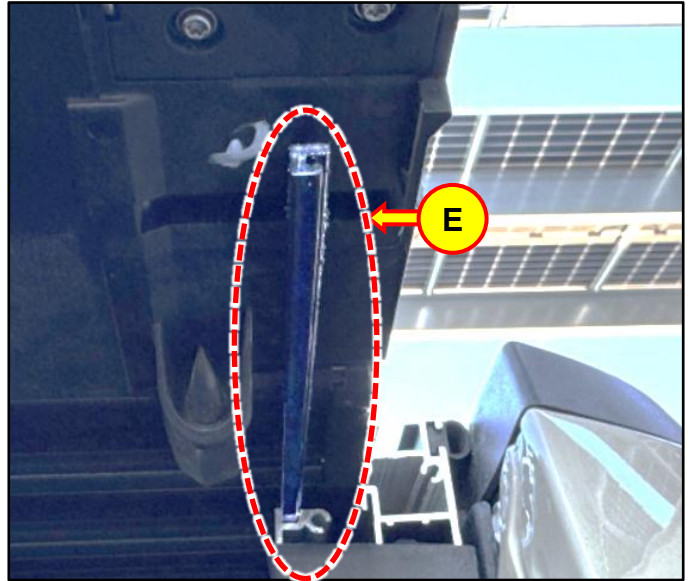
4. Visually inspect the plastic guide rails (E) under the tonneau cover for displacement.

Reinsert the plastic guide rail(s) into the track(s) if needed.

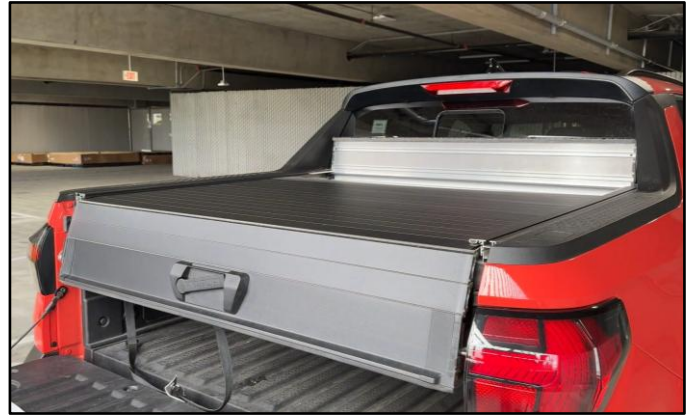
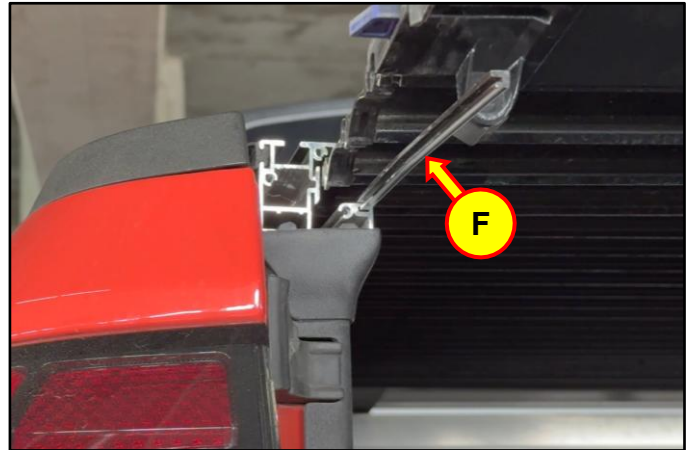
Before allowing the tonneau cover to droop outside of the tracks, visually inspect the plastic guide rails (F) under the tonneau cover for displacement.

Reinsert the plastic guide rail(s) into the track(s) if needed.

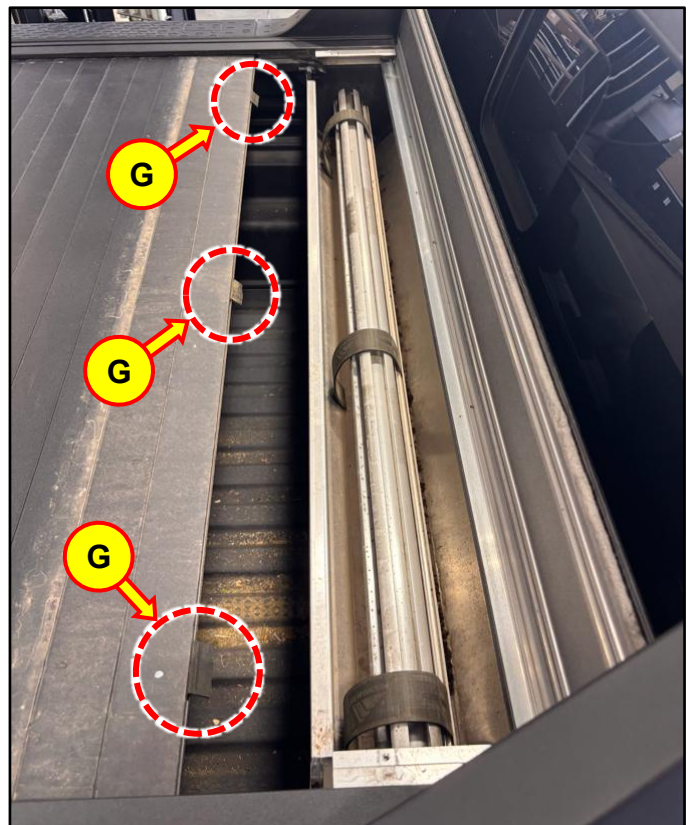
4. Check the tonneau cover for tension:
  - If the tonneau cover does **NOT** have any tension on it (**ALL** three rubber straps [G] are broken), continue to **step 5**.
  - If the tonneau cover has tension on it, proceed to **step 7**.
