# HYUNDAI

## Technical Service Bulletin

| GROUP<br><b>CAMPAIGN</b> | NUMBER<br><b>26-01-051H</b> |

**SUBJECT:** AC NOT TURNING OFF - ATCU SOFTWARE UPDATE  
(LIMITED COVERAGE CAMPAIGN LA29)

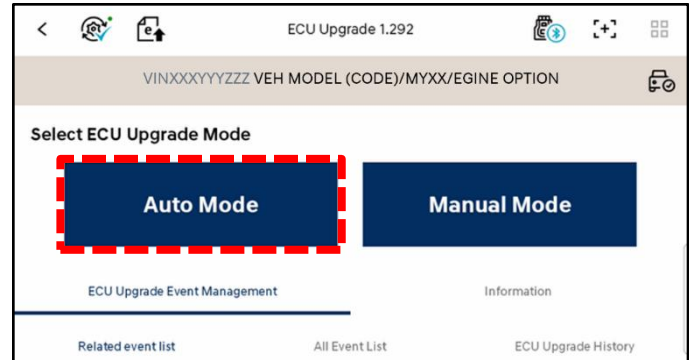
1. Perform the ECU update in **Auto Mode**.

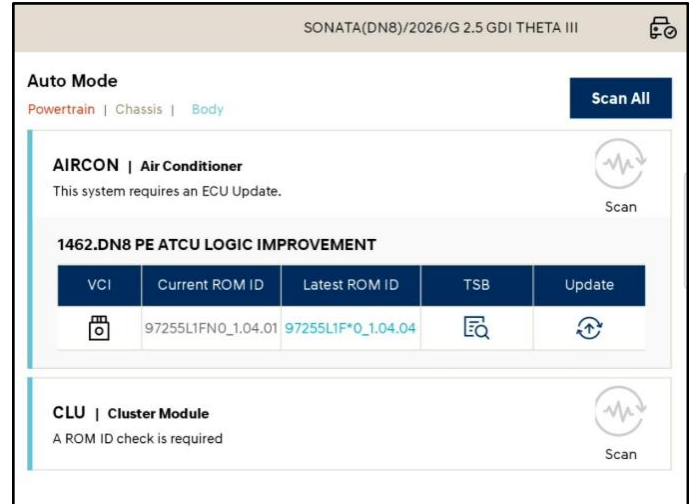
2. Verify the ROM ID by selecting the **AIRCON** system to scan the vehicle's current ROM ID.

If the update fails, remove the power connector from the in-cabin fuse box for at least **5 seconds**. Reassemble and retry the update.

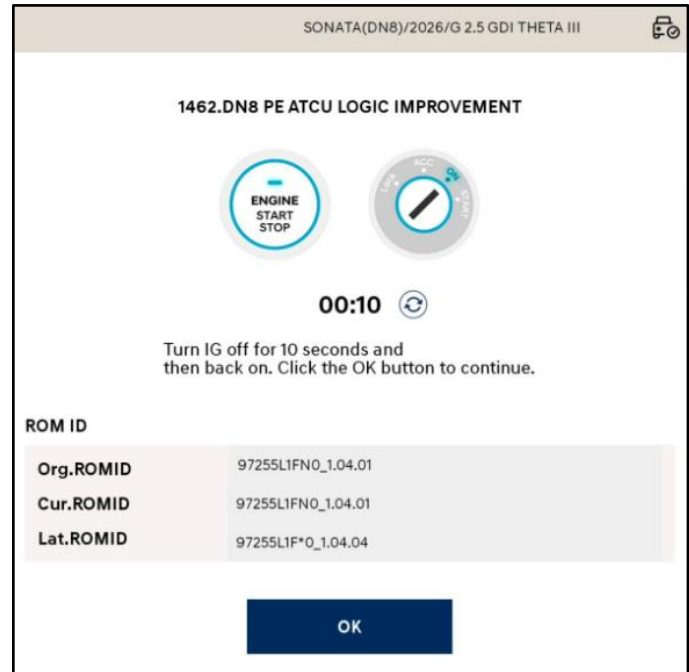
3. After the ECU update process shows 100% complete, follow the prompts on the screen to cycle the ignition **OFF** for at least **10 seconds** to reset the control unit (certain models may take up to **30 seconds**).

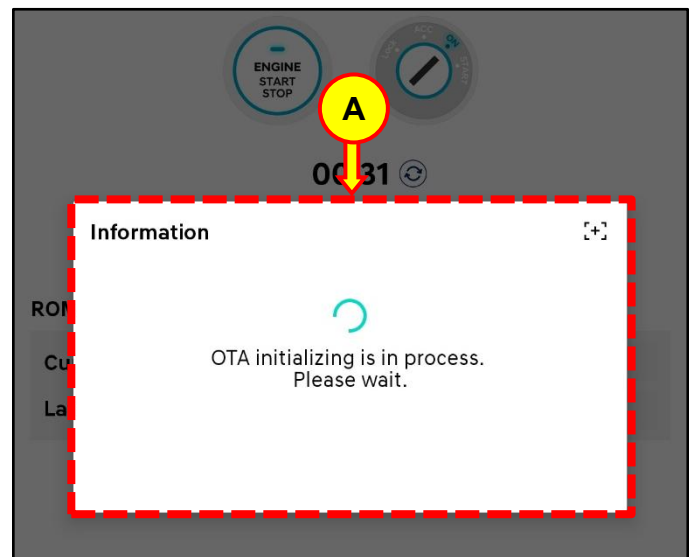
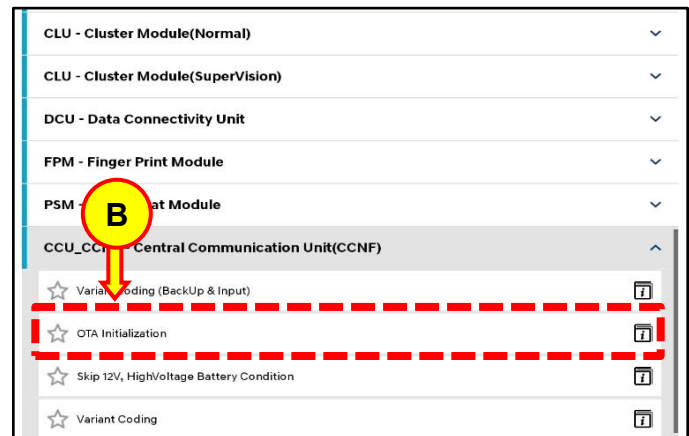
4. OTA initialization (A) should perform automatically:
- If OTA initialization performs automatically, then proceed with the service procedure.
  - If the OTA initialization process fails, complete it manually under:  
**S/W Management > CCU\_CCNF - Central Communication Unit (CCNF) > OTA Initialization (B).**

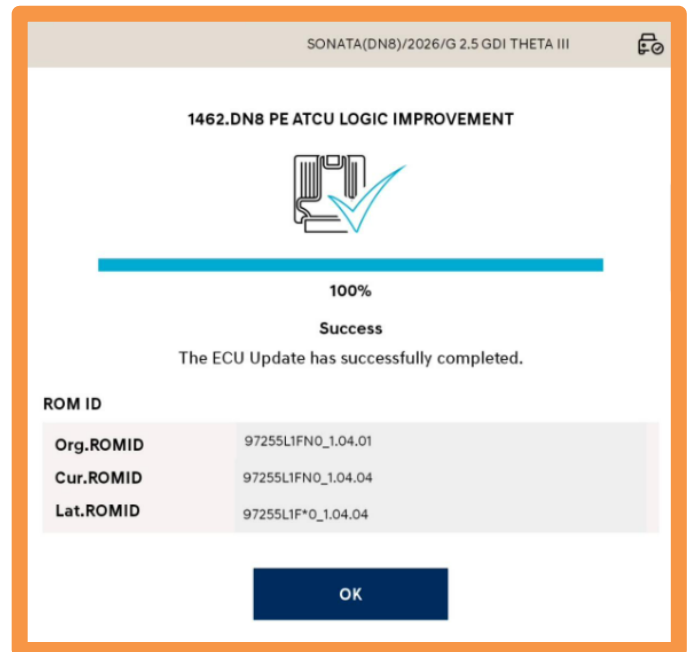
Using the tablet or GDS screen capture function, take a screenshot of the ECU Update “Success” result screen.

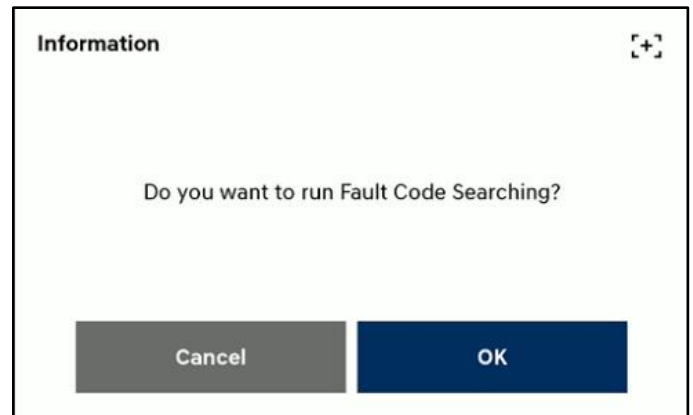
6. Perform an **All Systems Fault Code** search and erase DTC history that had incidentally occurred from the ECU update.
