**Technical Service Bulletin (TSB)**  
**R1H Radio USB Update to U41.17**

| REFERENCE: | TSB: 08-287-26<br>GROUP: 08 - Electrical | Date: | July 18, 2026 | REVISION: | — |
| VEHICLES AFFECTED: | 2026 (H1) Jeep Commander<br>2026 (M1) Jeep Compass<br>2026 (N4) RAM Rampage<br>This bulletin applies to vehicles built on or after January 01, 2026 (MDH 0101XX) and on or before April 26, 2026 (MDH 0426XX). | | | MARKET APPLICABILITY:<br><div><input checked="" type="checkbox"/> NA<input checked="" type="checkbox"/> MEA</div> <div><input checked="" type="checkbox"/> SA<input type="checkbox"/> IAP</div> <div><input type="checkbox"/> EE<input type="checkbox"/> CH</div><br><b>NOTE:</b> This bulletin applies to the North and South America, and Middle East & Africa markets. | |

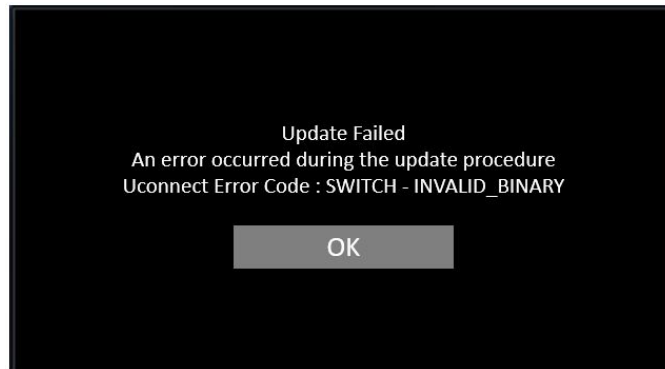
**Fig. 6**

Update Failed

16. **DO NOT** turn off the ignition at this point. The software update is still in process. Wait until the radio restarts and the home screen is displayed. This should take around five minutes.
17. If the radio displays an error pop up “ SWITCH-INVALID\_BINARY“ after successful radio update, ignore this error message and press “**OK**” to continue [Fig 6](#).
