## Technical Service Bulletin (TSB)

### Oil Leak Through The Rear Crankshaft Oil Seal (Flywheel Side)

| REFERENCE: | TSB: 09-010-26 REV. A<br>GROUP: 09 - Engine | Date: | July 17, 2026 | REVISION: | 09-010-26 |

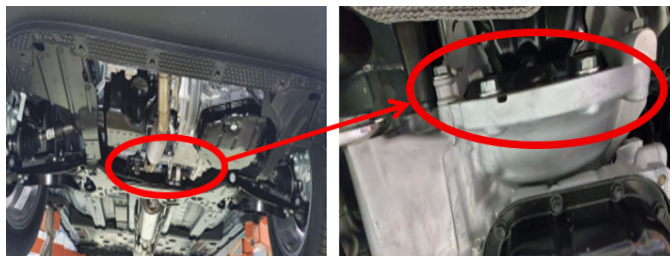
**Fig. 1**  
Area For Oil Leaks

4. Is there presence of oil in the coupling area between the engine and transmission [Fig. 1](#)?
  - YES >>> Proceed to [Step 5](#).
  - NO >>> Lower the vehicle. This bulletin has been completed, use Inspect LOP (09-25-75-9A) to close the active RSU.
5. Replace the rear crankshaft oil seal (flywheel side). Refer to the detailed service procedures available in DealerCONNECT/Service Library under: 1020D39 - Retentor Traseiro - Lado Volante - Remoção/Recolocação e Substituição, para Veículos com Câmbio Automático. Incluso Procedimentos Necessários.
