**Technical Service Bulletin (TSB)**  
**Difficulty Fueling Fuel Tank**

| REFERENCE: | TSB: 14-009-26<br>GROUP: 14 - Fuel System | Date: | July 16, 2026 | REVISION: | — |
| VEHICLES AFFECTED: | 2026 - 2027 (B1) Jeep Renegade<br>2026 - 2027 (M1) Jeep Compass<br>This bulletin applies to vehicles built on or after April 06, 2026 (MDH 0406XX) and on or before April 11, 2026 (MDH 0411XX). | | | MARKET APPLICABILITY:<br><div><input type="checkbox"/> NA<input type="checkbox"/> MEA</div> <div><input checked="" type="checkbox"/> SA<input type="checkbox"/> IAP</div> <div><input type="checkbox"/> EE<input type="checkbox"/> CH</div><br><b>NOTE:</b> This bulletin applies to the South America market. | |

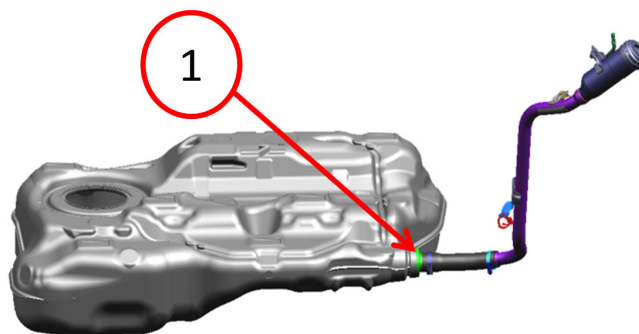
**Fig. 1**  
Fuel Tank Assembly

1. Open the fuel fill door.
2. Insert a borescope probe through the filler neck and attempt to open the inflow control valve [Fig. 1](#) using the end of the borescope.

1 - Inflow Control Valve

3. Was the inflow control valve operational?
  - YES >>> This bulletin has been completed. Use Inspect LOP (14-60-01-9P) to close the active RSU.
  - NO >>> The inflow control valve is stuck. Proceed to [Step 4](#).
4. Replace the fuel tank. Refer to the detailed service procedures available in DealerCONNECT/Service Library under: Service Info> 1040A10 - Reservatorio de combustivel - remocao/recolocacao e transferencia de combustivel . incluso procedimientos necesarios.
