**Technical Service Bulletin (TSB)**  
**Difficulty Fueling Fuel Tank**

| REFERENCE: | TSB: 14-009-26 REV. A<br>GROUP: 14 - Fuel System | Date: | July 17, 2026 | REVISION: | 14-009-26 |
| VEHICLES AFFECTED: | 2026 - 2027 (B1) Jeep Renegade<br>2026 - 2027 (M1) Jeep Compass<br>This bulletin applies to vehicles built on or after April 06, 2026 (MDH 0406XX) and on or before April 11, 2026 (MDH 0411XX). | | | MARKET APPLICABILITY:<br><div><input type="checkbox"/> NA<input type="checkbox"/> MEA</div> <div><input checked="" type="checkbox"/> SA<input type="checkbox"/> IAP</div> <div><input type="checkbox"/> EE<input type="checkbox"/> CH</div><br><b>NOTE:</b> This bulletin applies to the South America market. | |

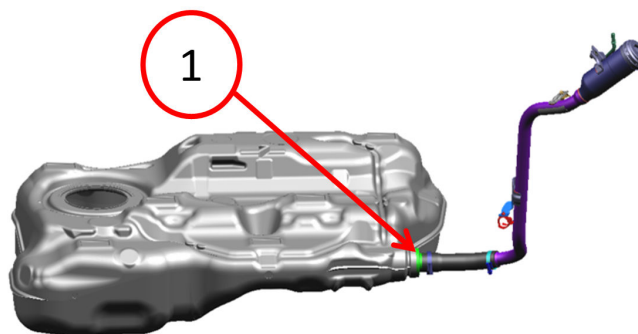
**Fig. 1**  
Fuel Tank Assembly

1. Open the fuel fill door.
2. Insert a borescope probe through the filler neck and attempt to open the inflow control valve [Fig. 1](#) using the end of the borescope.

1 - Inflow Control Valve

3. Was the inflow control valve operational?
  - YES >>> This bulletin has been completed. Use Inspect LOP (\*\*14-60-01-9S\*\*) to close the active RSU.
  - NO >>> The inflow control valve is stuck. Proceed to [Step 4](#).
4. Replace the fuel tank. Refer to the detailed service procedures available in DealerCONNECT/Service Library under: Service Info> 1040A10 - Reservatorio de combustivel - remocao/recolocacao e transferencia de combustivel . incluso procedimientos necesarios.
