## Technical Service Bulletin (TSB)

### Sunroof Shade Binding

| REFERENCE: | TSB: 23-027-26<br>GROUP: 23 - Body | Date: | July 15, 2026 | REVISION: | — |
| VEHICLES AFFECTED: | 2026 (WL) Jeep Grand Cherokee / Grand Cherokee L<br>This bulletin applies to vehicles built on or after May 04, 2026 (MDH 0504XX) and equipped with a Dual-Pane Panoramic Sunroof (Sales Code GWJ). | | | MARKET APPLICABILITY:<br><div><input checked="" type="checkbox"/> NA<input type="checkbox"/> CH</div> <div><input type="checkbox"/> EE<input type="checkbox"/> IAP</div> <div><input type="checkbox"/> SA<input type="checkbox"/> MEA</div><br><b>NOTE:</b> This bulletin applies to the North America markets. | |

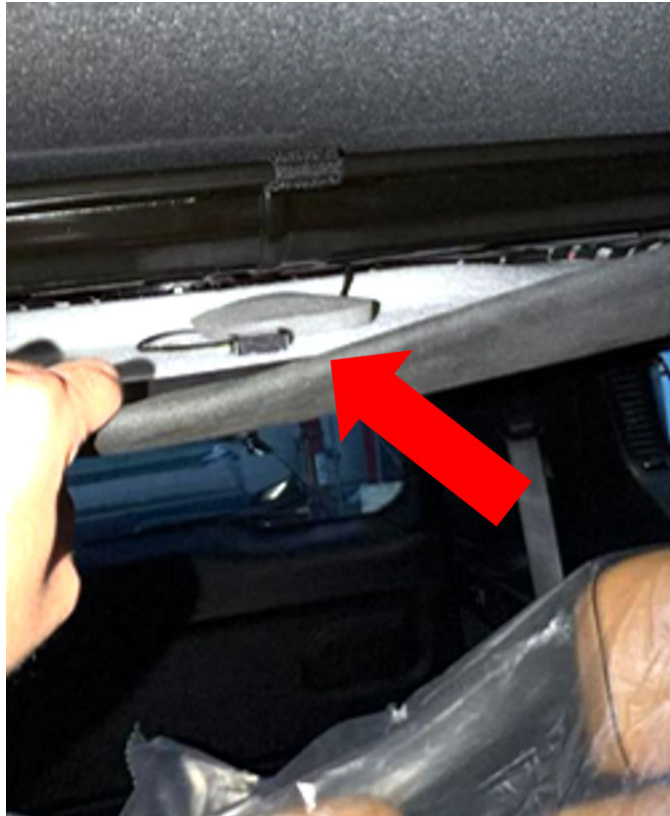
**Fig. 4**

3. Pull down the headliner from the rear of the opening to locate the second row microphone harness connector foam pad [Fig. 4](#).

Microphone Assembly Positioned On Back Headliner

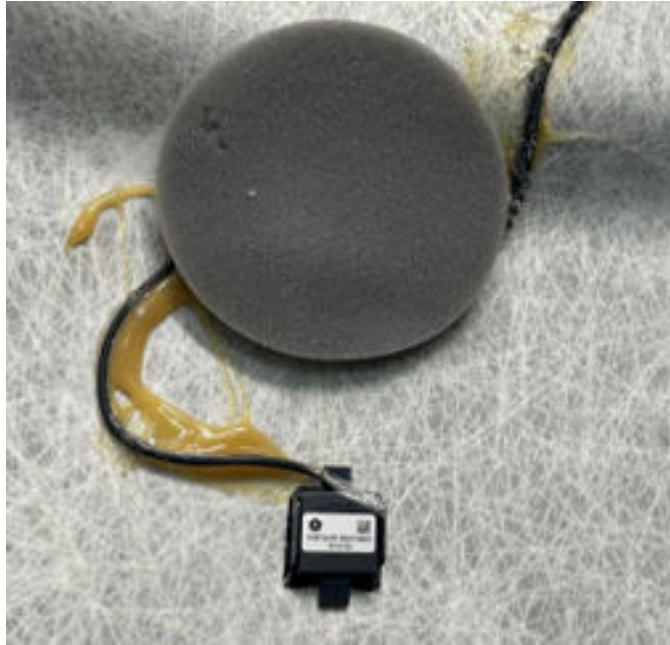
**Fig. 5**

4. Inspect the foam pad to verify the microphone harness connector foam pad is positioned behind the microphone [Fig. 5](#).

Correctly Positioned Foam Pad Behind The Microphone

5. Is the harness connector foam pad positioned behind the microphone [Fig. 5](#)?
  - YES >>> This bulletin has been completed. Use Inspect LOP (08-60-86-90) to close the active RSU.
  - NO >>> Proceed to [Step 6](#).

6. Carefully remove the foam pad from the microphone connector and headliner, and relocate the foam pad to behind the microphone [Fig. 5](#).
7. Fasten the headliner to the four hook and loop fasteners [Fig. 2](#) and [Fig. 3](#).
8. Install the trim ring on the dome lamp/Fam Cam interior camera [Fig. 1](#).
