**Technical Service Bulletin (TSB)**  
**Sunroof Shade Binding**

| REFERENCE: | TSB: 23-027-26 REV. A<br>GROUP: 23 - Body | Date: | July 17, 2026 | REVISION: | 23-027-26 |
| VEHICLES AFFECTED: | 2026 (WL) Jeep Grand Cherokee / Grand Cherokee L<br>This bulletin applies to vehicles built on or after **May 01, 2026 (MDH 0501XX) and on or before May 08, 2026 (MDH 0508XX)** equipped with a Dual-Pane Panoramic Sunroof (Sales Code GWJ). | | | MARKET APPLICABILITY:<br><div><input checked="" type="checkbox"/> NA<input type="checkbox"/> CH</div> <div><input type="checkbox"/> EE<input type="checkbox"/> IAP</div> <div><input type="checkbox"/> SA<input type="checkbox"/> MEA</div><br><b>NOTE:</b> This bulletin applies to the North America markets. | |

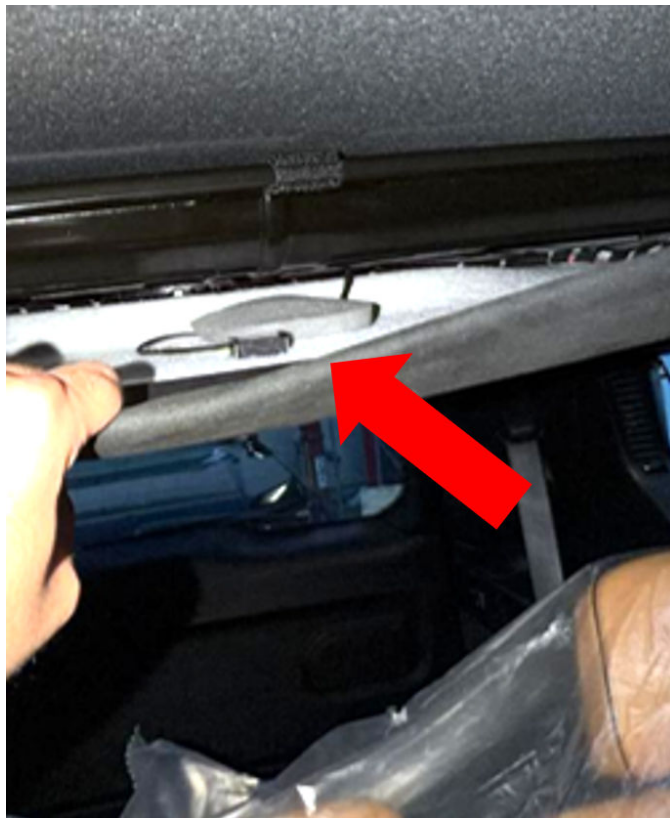
**Fig. 4**

Microphone Assembly Positioned On Back Headliner

4. Pull down the headliner from the rear of the opening to locate the second row microphone harness connector foam pad [Fig. 4](#).

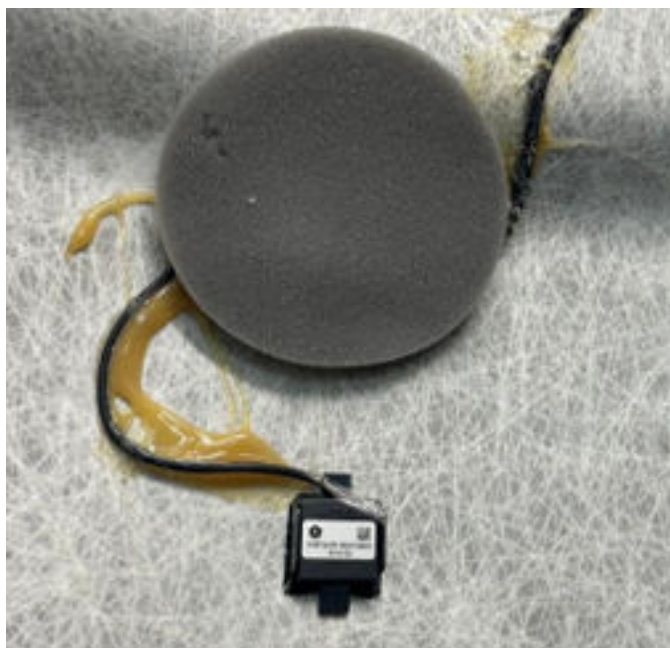
**Fig. 5**

| CUSTOMER SYMPTOM: | Customers may experience the following: <ul style="list-style-type: none"><li>The sunroof sunshade is binding or sticking while opening or closing the sunshade.</li></ul> <b>NOTE:</b> Some second row microphone harness connector foam pads may be catching on the sunroof sunshade track causing this condition. | | | | |
| CAUSE: | Second row microphone harness connector foam pad | | | | |

Correctly Positioned Foam Pad Behind The Microphone

5. Inspect the foam pad to verify the microphone harness connector foam pad is positioned behind the microphone [Fig. 5](#).

6. Is the harness connector foam pad positioned behind the microphone [Fig. 5](#)?
- YES >>> This bulletin has been completed. Use Inspect LOP (08-60-86-90) to close the active RSU.
  - NO >>> Proceed to [Step 6](#).

**IMPORTANT! Do not reposition the microphone connector. Only reposition the foam pad.**

7. Carefully remove the foam pad from the microphone connector and headliner, and relocate the foam pad to behind the microphone [Fig. 5](#).
8. Fasten the headliner to the four hook and loop fasteners [Fig. 2](#) and [Fig. 3](#).
9. \*\*Install the second row grab handles. Refer to the detailed service procedures listed in DealerCONNECT> Service Library under: 23 - Body / Interior / Handle, Grab / Installation.\*\*
10. Install the trim ring on the dome lamp/Fam Cam interior camera [Fig. 1](#).
