**Technical Service Bulletin (TSB)**  
**Front Passenger Seat**

| REFERENCE: | TSB: 23-028-26<br>GROUP: 23 - Body | Date: | July 17, 2026 | REVISION: | — |
| VEHICLES AFFECTED: | 2025 - 2026 (MW) Jeep Compass<br>This bulletin applies to vehicles built on or before May 15, 2026 (MDH 0515XX) equipped with Heated Front Seats (Sales Code JPM). | | | MARKET APPLICABILITY:<br><div><input type="checkbox"/> NA<input type="checkbox"/> MEA</div> <div><input type="checkbox"/> SA<input type="checkbox"/> IAP</div> <div><input checked="" type="checkbox"/> EE<input type="checkbox"/> CH</div><br><b>NOTE:</b> This bulletin applies to Enlarged Europe markets. | |

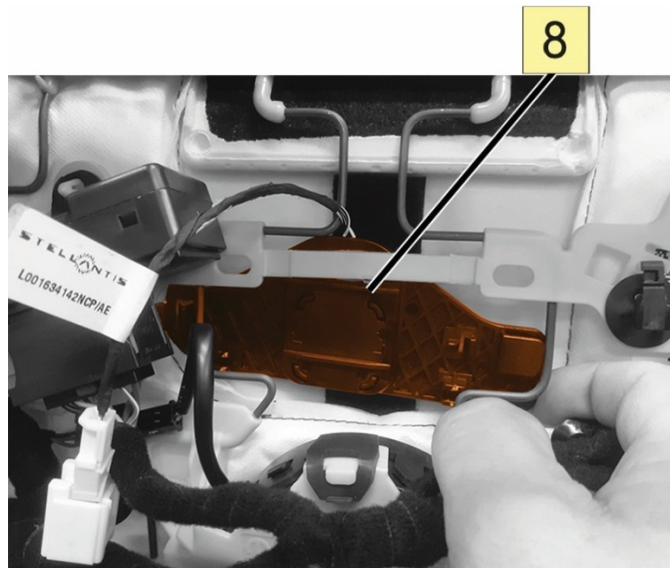
**Fig. 6**

**NOTE:** In case of breakage of SBR plate plastic snap-fits, the component needs to be replaced with a new one.

11. Disconnect the SBR connector (7) from the wire harness.
12. Carefully remove the SBR sensor (8) from the cushion suspension.

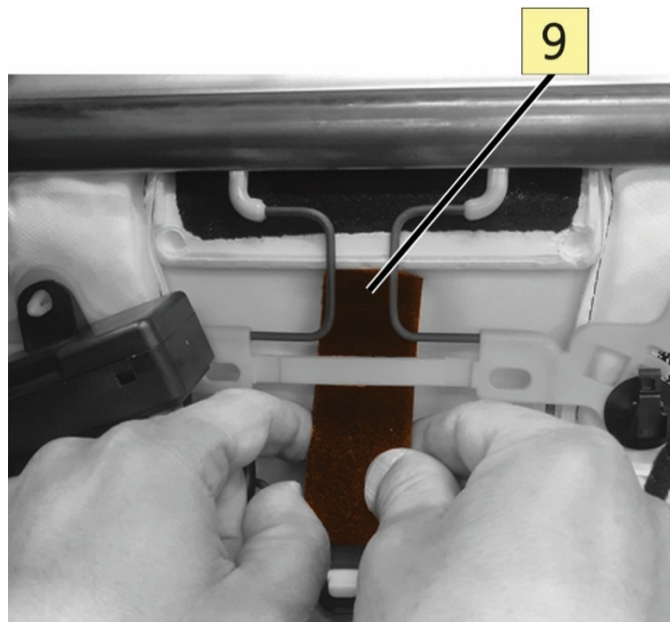
**Fig. 7**

| CAUSE: | Insufficient foam deformation inside the front seat pad | | | | |

13. Prepare, in advance, a double felt by gluing one on top the other.
14. Apply and stick the double felt (9) on the cushion foam pad SBR cavity, centrally and aligning it on the extremities of the cavity.
