## Technical Service Bulletin (TSB)

### Lifgate Tail Lamp Assembly Condensation/Water Intrusion

| <b>REFERENCE:</b> | <b>TSB:</b> 23-029-26<br><b>GROUP:</b> 23 - Body | <b>Date:</b> | July 18, 2026 | <b>REVISION:</b> | — |
| <b>VEHICLES AFFECTED:</b> | <b>2025 - 2026 (GC) Alfa Romeo Tonale</b><br>This bulletin applies to vehicles built on or after June 20, 2025 (MDH 0620XX) and on or before February 06, 2026 (MDH 0206XX). | | | <b>MARKET APPLICABILITY:</b><br><div style="display: flex; justify-content: space-between;"> <div> <input checked="" type="checkbox"/> NA<br/> <input type="checkbox"/> EE<br/> <input type="checkbox"/> SA </div> <div> <input type="checkbox"/> CH<br/> <input type="checkbox"/> IAP<br/> <input type="checkbox"/> MEA </div> </div> <p><b>NOTE:</b> This bulletin applies to the North America markets.</p> | |

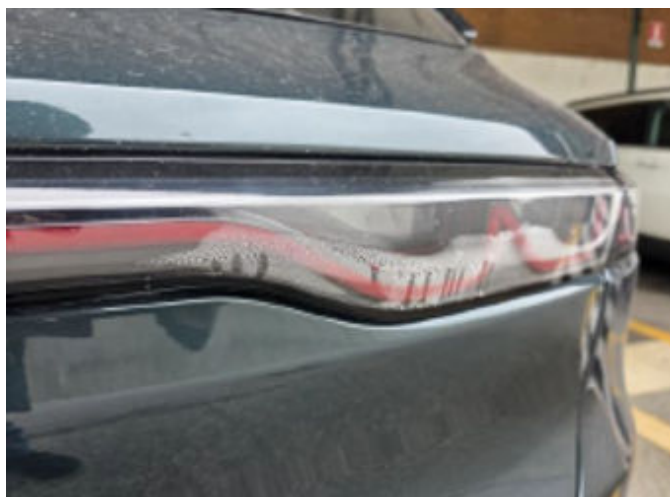
**Fig. 1**

| <b>CUSTOMER SYMPTOM:</b> | <b>Customers may comment on the following:</b> <ul style="list-style-type: none"> <li>Condensation/water intrusion can be seen inside the liftgate tail lamp assembly.</li> </ul> | | | | |
| <b>CAUSE:</b> | Material defect | | | | |

1. Inspect the liftgate tail lamp assembly for condensation or water intrusion [Fig. 1](#).

Liftgate Tail Lamp Assembly Water Intrusion

2. Was any condensation or water intrusion observed?
  - YES >>> Proceed to [Step 3](#).
  - NO >>> This bulletin has been completed. Use Inspect LOP (08-50-89-9A) to close the active RSU.
3. Replace the liftgate tail lamp assembly. Refer to the detailed service procedures listed in DealerCONNECT> Service Library under: 08 - Electrical / 8L - Lamps and Lighting / Lamps/Lighting - Exterior / Lamp, Tail / Removal and Installation.

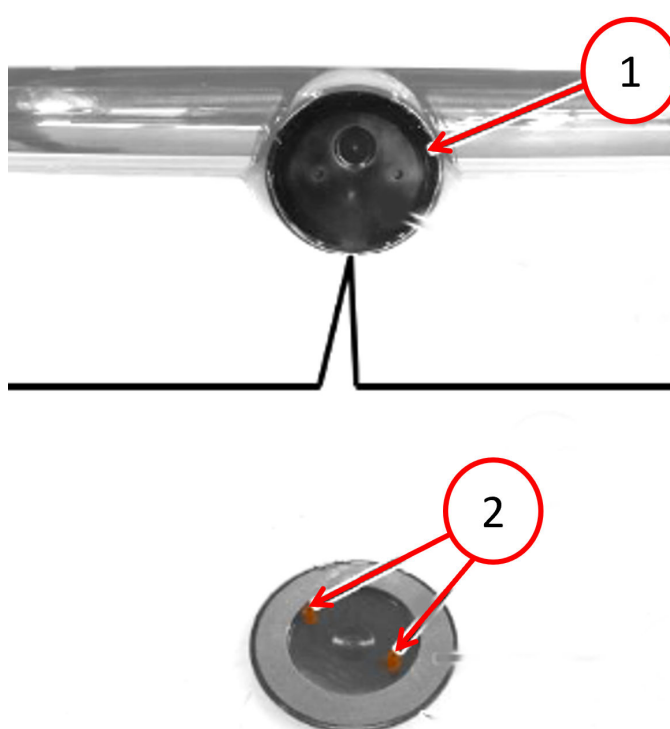
**Fig. 2**

New Nameplate Installation

1 - Liftgate Tail Lamp Nameplate Mounting Surface  
2 - New Nameplate Locators

**NOTE: Do not remove and reuse the old nameplate.**

**NOTE: Do not touch the new rear nameplate adhesive surface during installation. Bond at an ambient temperature of no less than 18-20 °C (64-68 °F).**

4. Install the **NEW** rear nameplate by removing the protective film from the adhesive back and positioning the nameplate on the inner tail lamp assembly engaging the locators [Fig. 2](#). Ensure proper adhesion by pressing evenly on the nameplate.
