## STAR ONLINE PUBLICATION

**Case Number:** S2608000033

**Symptom/Vehicle Issue:** Cluster Message “To Operate Tailgate Shift to Park” Vehicle is In Park

2019-2024 Ram 1500 (DT)

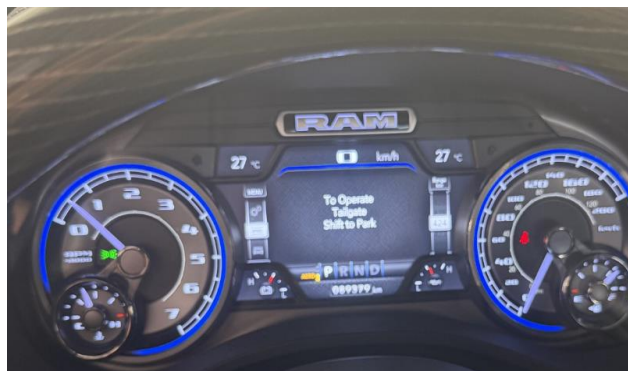
**Discussion:** There have been reports that if a vehicle is equipped with the multifunction liftgate sales code (MWK) and the liftgate module was replaced with a 2025 liftgate module on an older vehicle it will display a message as shown. Inspect the part number of the module that was installed to ensure the correct module part for the year was installed.
