**July 7, 2026**

**Vibration or Rattle Noise from Front Passenger-Side Dashboard****APPLIES TO**

| Year | Model | Trim Level | VIN Range |
|---|---|---|---|
| 2024–26 | Civic | 4-Door | ALL |

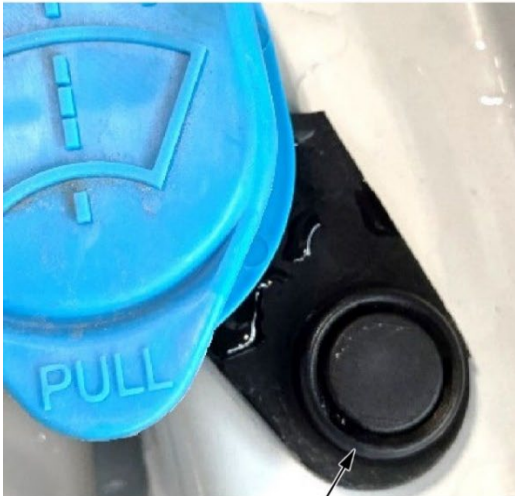
91505-S9A-003

**NO GOOD** ❌

NOTE: If the original cover clip is installed (**P/N 91505-S9A-003**), replace it with the updated cover clip (**P/N 91505-TY2-003**) during assembly.

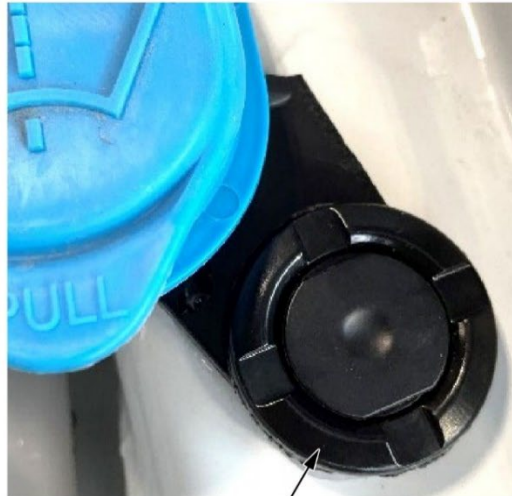
91505-TY2-003

**GOOD** ✅
