Service Campaign Notification

| Campaign # | Description | Replace the Transmission Control Unit |

| SUBJECT | Replace Transmission Control Unit |
| MODEL(S) | S-class (223.179/979 with engine 279 and transmission 725.0) |

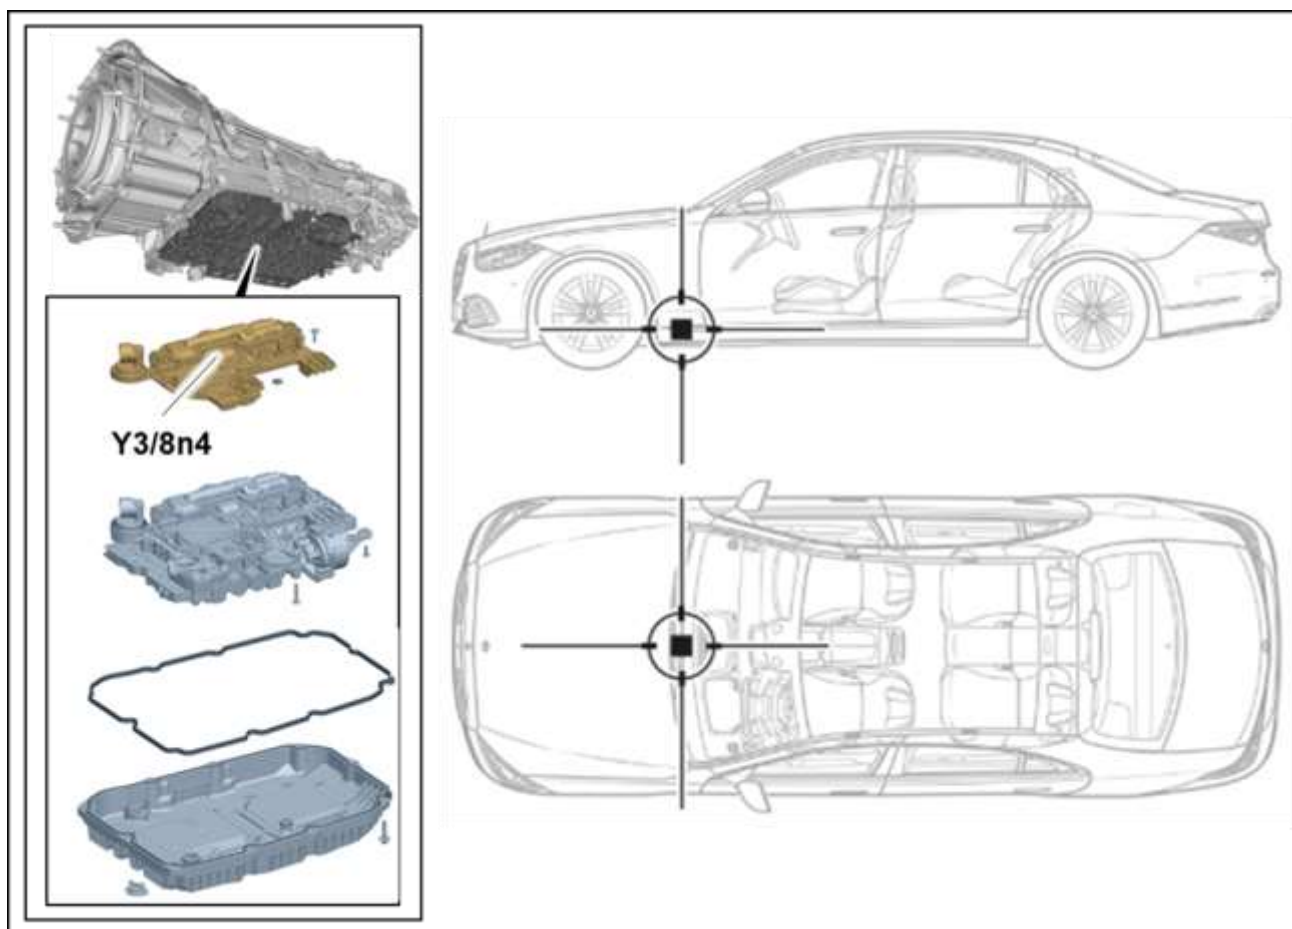
**Illustration 2**

| Issue | The transmission control unit (VGS) in the automatic transmission does not comply with our currently valid specifications in the vehicles of the above-mentioned model series delivered to you. It is possible that the polarities of the magnets in the transmission control unit (VGS) have been swapped. This could in turn result in shift quality issues and gear lockouts. | | |

1. Connect XENTRY Diagnosis.
2. Replace control unit for fully integrated transmission controller (Y3/8n4, **Illustration 2**) on automatic transmission.

Before removing the control unit for the fully integrated transmission controller (Y3/8n4, **Illustration 2**), read out and save the adaptation values stored using the diagnostic system.
