2025-2026MY  
K4 (CL4)

414 (Rev 1, 07/21/2026)

## TECHNICAL SERVICE BULLETIN

SUBJECT: BODY DOMAIN CONTROLLER (BDC) REPLACEMENT (CA2515)

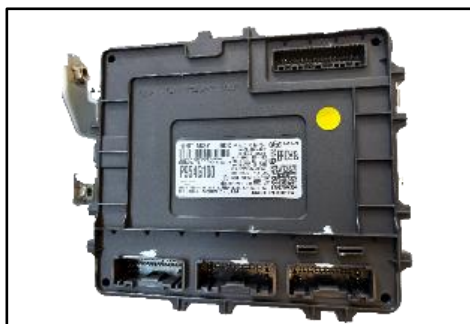
This bulletin provides information regarding the Body Domain Control unit 'BDC' on certain 2025MY and 2026MY K4 (CL4) vehicles manufactured from May 1, 2025, through February 9, 2026. Due to a communication issue between the key fob and the BDC, the affected vehicles may exhibit a NO START condition when the ignition 'START' button is pressed; however, all other key fob functions such as the Lock/Unlock, Trunk Release, Alarm, and Remote Start continue to operate normally. Follow the procedure outlined in this publication to replace the BDC. Before conducting the procedure, verify that the vehicle is included in the list of affected VINs.
