## Technical product information

| <b>Topic</b> | Creaking/squeak noise from the front suspension (upper inner lever bushes) |
| <b>Brand</b> | Bentley |
| <b>Transaction No.</b> | 2064779/7 |

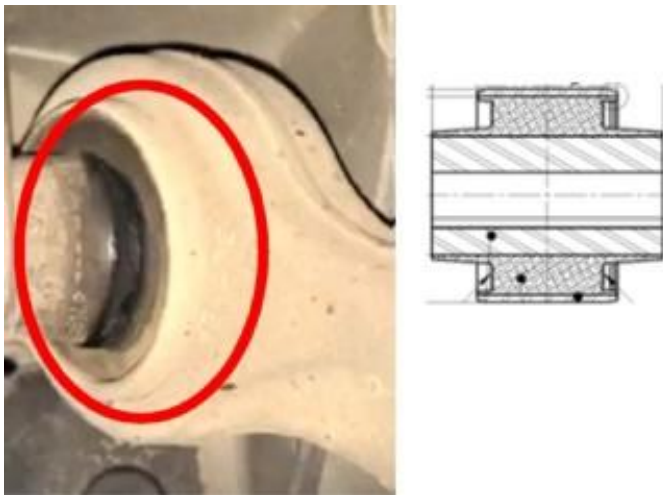
Figure 1

Defective upper inner lever bush (Figure 1)

The noise present in the sound file is caused by defective upper inner lever bush/bushes, the noise can appear in the following possible scenario

1) Replace the left hand front (x2) and right hand front (x2) upper inner lever bushes - Refer to Repair manual Rep.Gr.40 front suspension, upper lever bush/bushes - to remove and fit
