# Technical product information

| Topic | Drive System Fault in Kombi with DTC P0C5100 present Continental GT/GTC/Flying Spur |
| Transaction No. | 2080242/3 |

Drive System Fault in Kombi with DTC P0C5100 present | Continental GT/GTC  
/Flying Spur

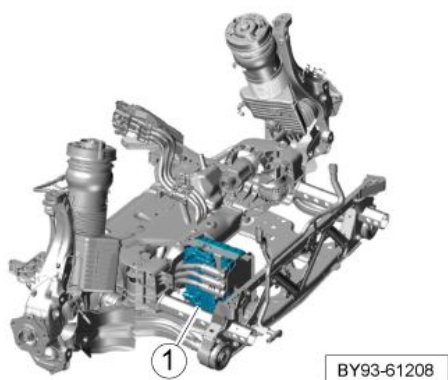
**Figure 1.** Electric Drive Control Unit Location -A37-

The electric drive control unit (DC/AC converter for drive motor -A37- ) -1- is located on the right-hand side of the front sub-frame.

Check T8aa (8-pin connector, black), TMR (Coupling point in engine compartment, right), and T32am (32-pin connector, black) for:

- Physical damage (broken housing, bent pins, cracked insulation)
- Pin drag (verify terminal tension using correct test tool)
- Corrosion or contamination (look for rust, green deposits, dirt, oil, moisture)

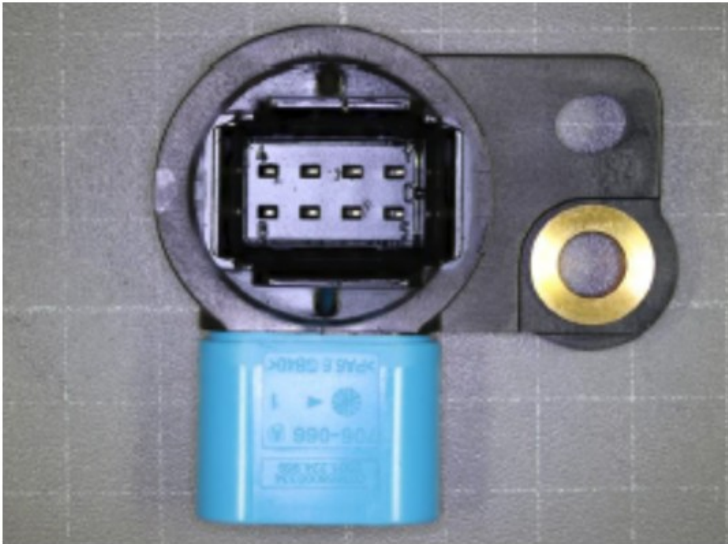
**Figure 4.** 90° connector (PN 0DS907226A)

Incorrect or unstable signals from the drive motor position sensor can disrupt torque control and trigger fault codes in the Electric Drive system.

Replacement of the 90° connector (PN 0DS907226A) shown in figure 4 below is only permitted once all required diagnostic information has been submitted in accordance with the stated requirements and approval has been granted via DISS; thereafter, follow the procedure outlined below.

4. Replace 90° connector (PN 0DS907226A) once approval has been granted via the existing DISS query.
