## Technical product information

| <b>Topic</b> | DTC B17B801 and/or B17B804 - evident within address 0019 and/or DTC U112300 evident in 00A5 |
| <b>Transaction No.</b> | 2063855/13 |

# New Continental GT/GTC - New Flying Spur - Bentayga Series

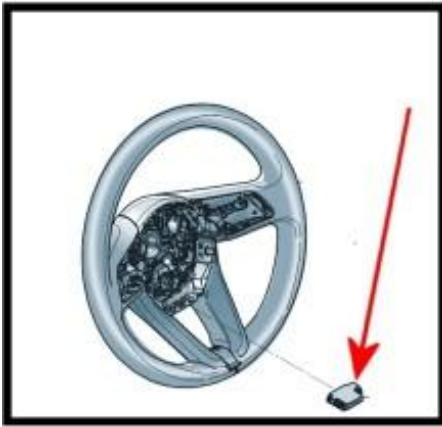
- Lane Assist and / or Traffic Assist are not functional
- DTC - B17B801 - Steering Wheel Touch Recognition Control Module evident within address 0019

- DTC B17B804 - Steering Wheel Touch Recognition Control Module electrical error - evident within address 0019

- 1) Referring to Rep.Gr 69 - Remove the driver's air bag
- 2) Referring to Figure 1 - Replace the Steering Wheel Contact Detection control unit (J1158)

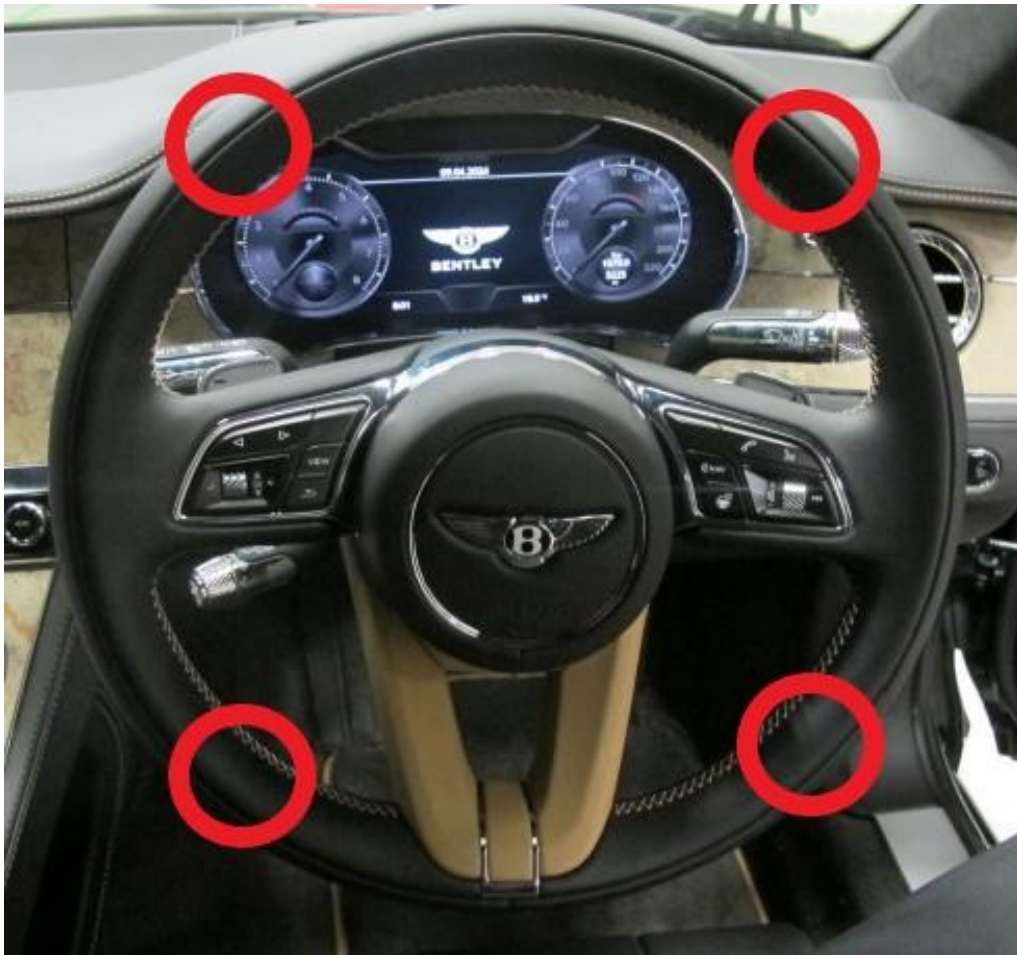
- Monitor the Sensor 2 and Sensor 3 values whilst holding the steering wheel at the points shown - **The expected values are between 40 and 60 and No malfunction Detected**

| Sensor 2 and sensor 3 should recognise contact with the steering wheel and will show the values changing if the system is working to specification |

- Place hands (light grip) on the steering wheel at the various points as shown in Figure 3

In the event the issue is not resolved the operative should raise a DISS query requesting permission to replace the steering wheel
