## Technical product information

**2068946/12**

Dynamic ride system warning visible - DTC P0B2500 logged within address 0021  
(Battery Energy Control Module 2)

Release date: 16 Jul  
2026

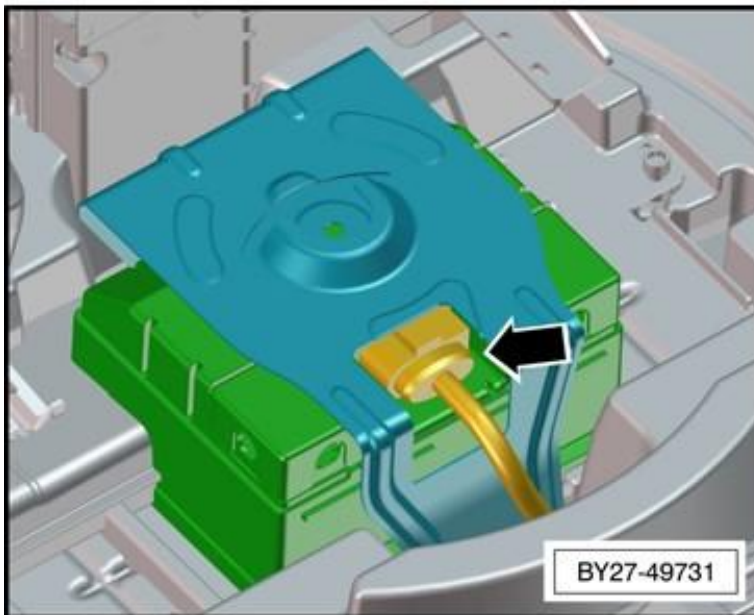
3) Referring to Figure 2 - Check the security of the harness connector

- In the event the harness connector is not secure the operative must secure the connector

**Should an issue be identified with the connector or super capacitor which doesn't allow the connector to be secured the operative must feedback via DISS**
