**Technical Service Bulletin (TSB)**  
**M1 H1 Coolant Leak**

| REFERENCE: | TSB: 07-005-26<br>GROUP 07 - Cooling | Date: | July 21, 2026 | REVISION: | 07-001-23 REV. A |
| VEHICLES AFFECTED: | 2022 - 2023 (M1) Jeep Compass<br>2022 - 2023 (H1) Jeep Commander<br>This bulletin applies to vehicles built on or after May 03, 2022 (MDH0503XX) and on and before November 07, 2022 (MDH1107XX) equipped with a 2.0L I4 Turbo Diesel Engine (Sales Code EBT). | | | MARKET APPLICABILITY:<br><div><input type="checkbox"/> NA<input type="checkbox"/> MEA</div> <div><input checked="" type="checkbox"/> SA<input type="checkbox"/> IAP</div> <div><input type="checkbox"/> EE<input type="checkbox"/> CH</div> <div>NOTE: This bulletin applies to South America markets.</div> | |

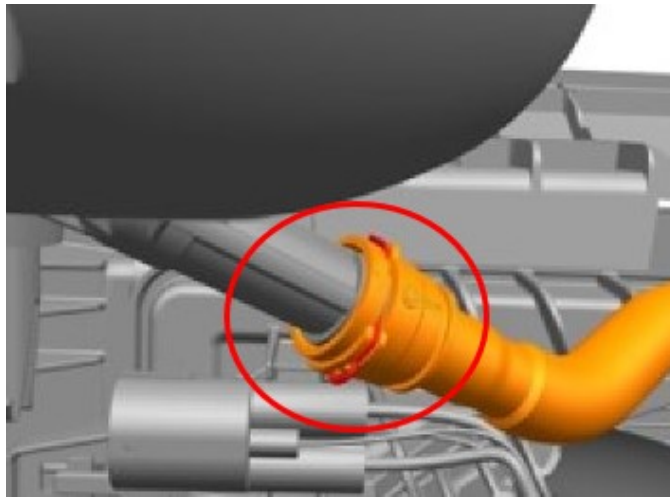
**Fig. 2**

Quick Disconnect At Coolant Reservoir

4. Disconnect quick disconnect at lower coolant reservoir [Fig. 2](#).

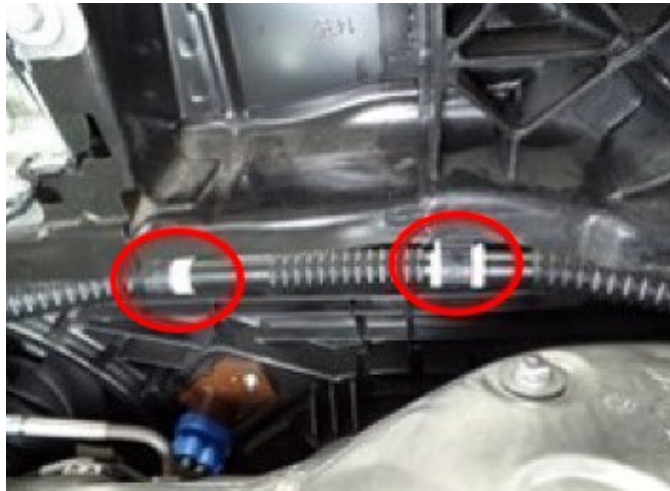
**Fig. 3**

| CAUSE: | Coolant hose not secured in its retainer | | | | |

Hose At Retainers

5. Remove hose from hose retainers [Fig. 3](#).

7. Remove hose assembly.
8. Install new hose assembly.
9. Install hose into hose retainers.
10. Connect lower radiator hose clamp at engine.
11. Connect lower radiator hose quick disconnect at radiator.
12. Connect quick disconnect at lower coolant reservoir.
13. Refill cooling system. Refer to the detailed service procedures listed in DealerCONNECT>Service Library under: 07 - Cooling / Standard Procedure.
14. Install engine belly pan. Refer to the detailed service procedures listed in DealerCONNECT>Service Library under: 13 - Frame and Bumpers / Under Body Protection / Belly Pan / Installation.

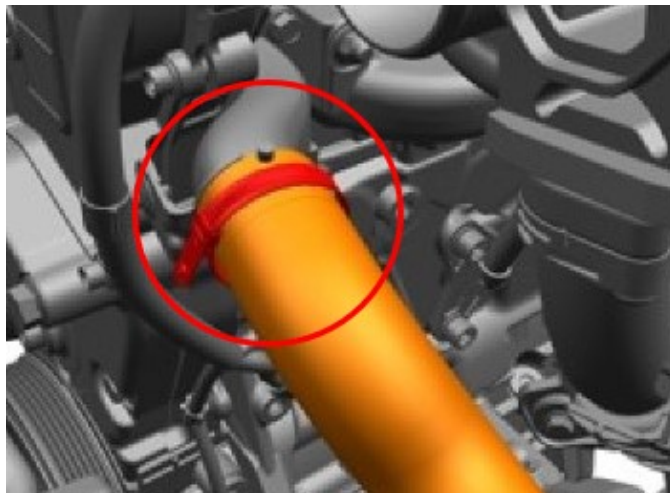
**Fig. 4**

Radiator Hose At Cylinder Head

6. Disconnect lower radiator hose clamp at cylinder head [Fig. 4](#).
