**Technical Service Bulletin (TSB)**  
**Telematics Box Module (TBM) Firmware Over The Air (FOTA) Software Updating from 4.37 Or 4.38 To 4.39**

| REFERENCE: | TSB: 08-294-26<br>GROUP: 08 - Electrical | Date: | July 25, 2026 | REVISION: | — |
| VEHICLES AFFECTED: | 2021 - 2024 (WD) Dodge Durango<br>This bulletin applies to vehicles equipped with Global Telematics Box Module (TBM) (Sales Code RDG). | | | MARKET APPLICABILITY:<br><div><input checked="" type="checkbox"/> NA<input type="checkbox"/> MEA<br/><input type="checkbox"/> SA<input type="checkbox"/> IAP<br/><input type="checkbox"/> EE<input type="checkbox"/> CH</div><br>NOTE: This bulletin applies to the North American markets. | |

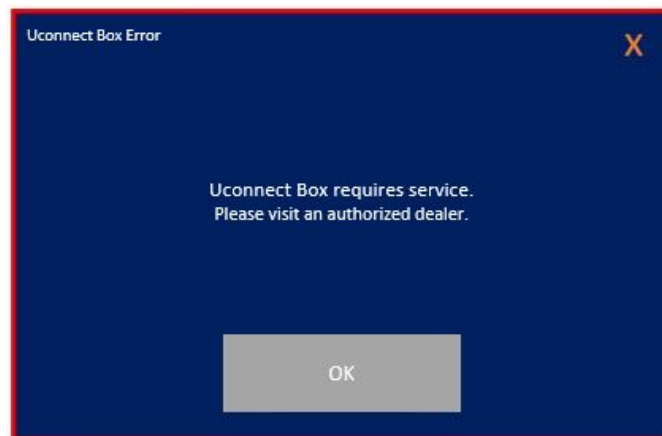
**Fig. 1**

Uconnect Box Error Message

Message display on the radio screen, "Uconnect Box requires service. Please visit an authorized dealer." [Fig. 1.](#)

**NOTE:** "Uconnect Box requires service." message can be triggered by different reasons. For an issue on a new vehicle recently switched to customer mode, please follow the New Vehicle Preparation procedure to resolve the issue. For the customer vehicle with intermittent concerns, please check the TBM, antenna and instrument panel harness connections to fix related DTC issues.

This bulletin provides information regarding the latest Firmware Over The Air (FOTA) update and provides the service technician an overview of the steps a customer will need to take to complete the update. The TBM2 software will be updated from 4.37 (SW P/N 68604567AC) or 4.38 (SW P/N 68604567AD) to 4.39 (SW P/N 68604567AE).

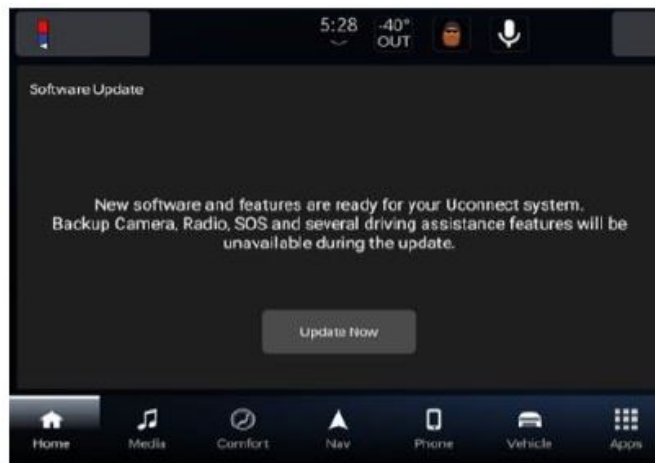
**Fig. 2**  
Software Acceptance Screen

1. The vehicle needs to be in ‘Park’. The ignition needs to be in the Off position.
2. If the customer selects “Update Now” [Fig. 2](#) they can shut off the vehicle and leave. The update will be completed automatically.

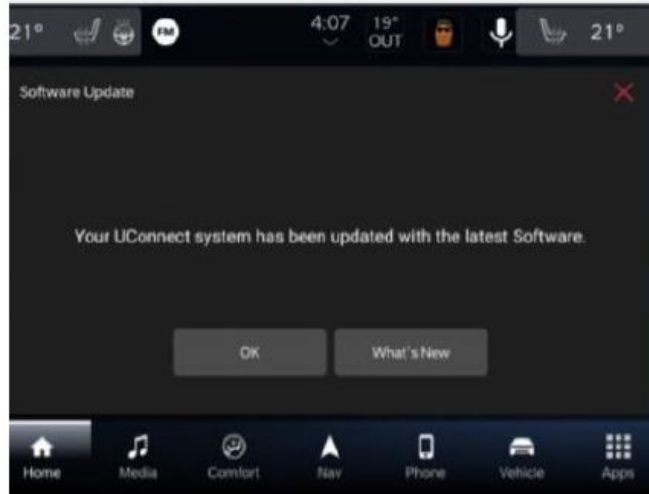
**Fig. 3**  
Software Update Confirmation Screen

3. Upon completion of update, the radio will display a confirmation message [Fig. 3](#).
