# CUSTOMER SATISFACTION NOTIFICATION

## Spark Plugs

Reference: 66D

2026 (WL) Jeep Grand Cherokee

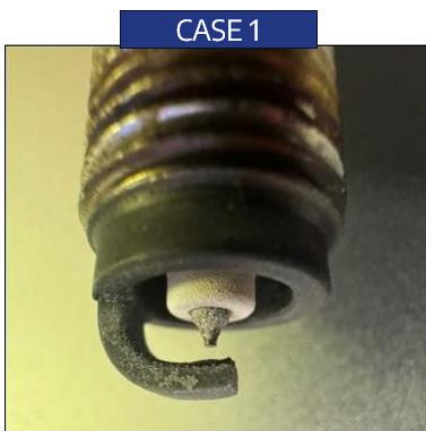
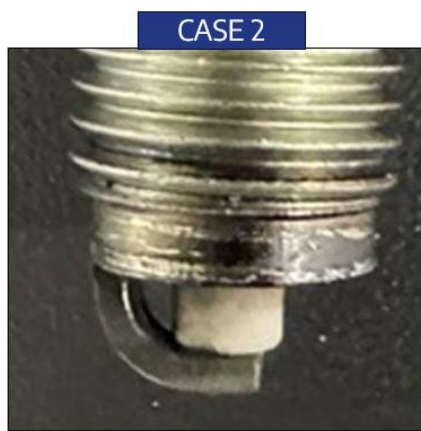
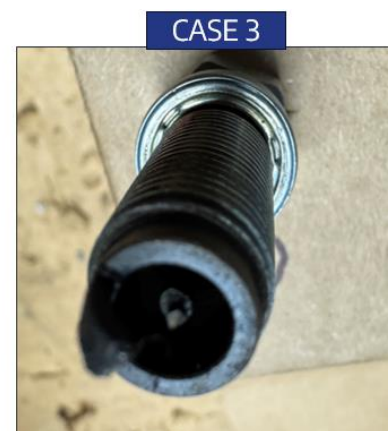
The spark plugs insulator on approximately 48,000 of the above vehicles may break due to excessive cylinder pressure. This pressure can cause the spark plug's ceramic insulator to crack, leading to a rough-running engine. If this issue is not resolved promptly, the broken fragments can fall into the cylinder and cause internal engine damage.

**Case 1** – Spark Plug ceramic **not broken**. Proceed with spark plug replacement step 20.

**Case 2** – Spark Plug ceramic **broken** but not fallen into combustion chamber. Proceed with spark plug replacement step 20.

**Case 3** – Spark Plug **ceramic broken and fallen** into combustion chamber, proceed to repair according to Star Online (SOL S2618000003) published in Service Library.

19. Remove the main spark plug from the cylinder head using a quality thin wall socket with a rubber or foam insert and inspect the condition of the spark plug electrode and ceramic insert. Reference the condition of the removed spark plugs to the illustration below.

20. Install the main chamber spark plugs and tighten to 18N·m (13ft. lbs.).
21. Reinstall main chamber ignition coils and tighten nuts to 9N·m (80In. lbs.).
22. Reconnect the main ignition coil(s) wire harness connector(s).
23. Install the top soundproofing from the valve cover and attach the retainer (Figure 3).
24. Connect the charge air cooler inlet tube.
25. Install the charge air cooler, inlet tube bolt to valve cover and tighten to 8N·m (80In. Lbs.) (Figure 2).
26. Install the CAC inlet tube bolts and connect it to the turbocharger and tighten to 11N·m (8Ft, Lbs.). (Figure 2).
27. Connect the clip and connect the CAC inlet tube to the throttle body and the CAC hose.
28. Connect the crankcase pressure sensor electrical connector and harness retainer.
29. Connect the inlet temperature sensor wire harness connector and engage lock (Figure 2).
