# Service Bulletin

Bulletin No.: PIT5680B

**Subject: Water / Ice In Door Sill Plate Area or When Opening A Door Water Drains From The Bottom of the Door**

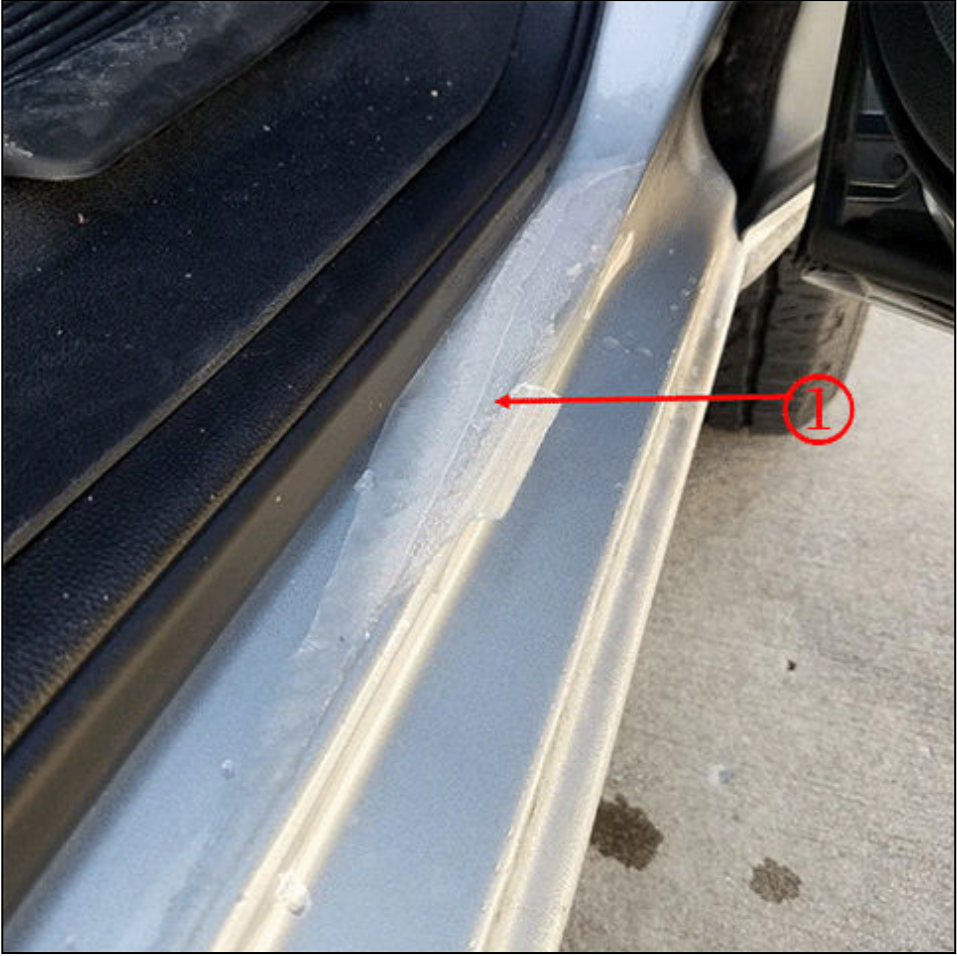
| Condition | <p data-bbox="531 185 1476 286">Some customers may notice water accumulating on the sill plate between the body and the door seals when a door is opened. In some cases, water may also drain from the bottom of the door after the door is opened. If outside temperatures are below freezing, the trapped water may freeze on the sill plate, as shown in the image below (1).</p> <p data-bbox="1425 1283 1492 1305">5321090</p> |

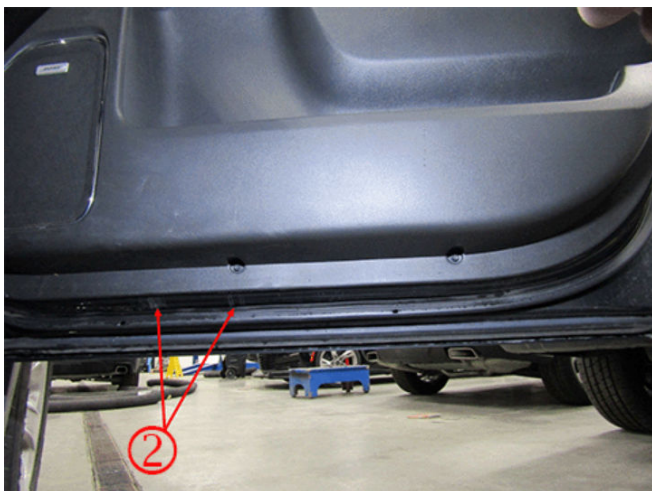
| Cause | <p data-bbox="531 1317 1476 1395">This concern may be caused by the door water barrier/deflector butyl not being sealed to the door. When inspecting the bottom of the door, water stains may be found coming from below the door trim panel, as shown below (2).</p> |

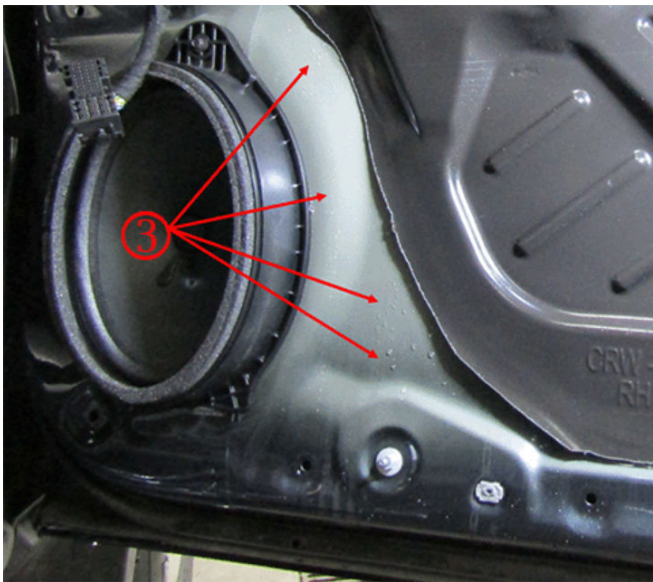
5321096

- If water is found leaking out from underneath the door trim panel, remove the door trim panel for further inspection.
- With the door trim panel removed, inspect for water droplets on the door sheet metal, as shown below (3). This will give you an idea/area where the door water barrier/deflector is not sealed properly, as shown below (4). If the door water barrier/deflector is gently pulled away from the door it will come free with little effort, which is an indication it was not sealed to the door properly.

- Dry any water from the door and reinstall the door water barrier/deflector.
- With the door water barrier/deflector in place, use a roller or socket to help seal the water barrier/deflector butyl to the door.
