# Service Bulletin

Bulletin No.: PIT6300C

**Subject:** Buzz, Rattle, Vibration Noise from the Passenger Side When Vehicle Is Under Light Load - Possible Slow/No Crank Or Alternator Not Charging

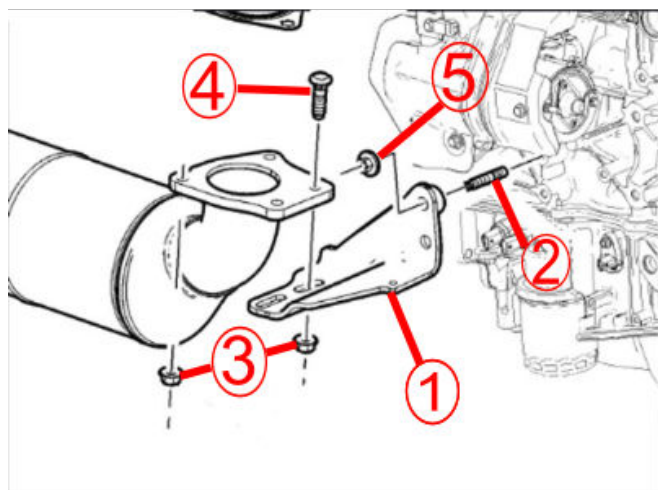
6908613

| Condition | Buzz/Rattle/Vibration/Noise from the passenger side when the vehicle is under light load. Possible Slow/No Crank or alternator not charging. |
| Cause | Inspect for a cracked catalytic converter bracket (1), and/or missing/broken hold down studs (2,4), as shown below. |

If using the GM NVH PICO scope, a severe in cabin E3 vibration may be present.

If diagnosing a slow/no crank or alternator not charging, there will be a high voltage drop from the battery to the engine block.

Inspect the catalytic converter brace/bracket for cracks or missing hold down stud and/or nuts.

Repair as needed.
