# Service Bulletin

Bulletin No.: PIT6218D

**Subject:** SES light P059F

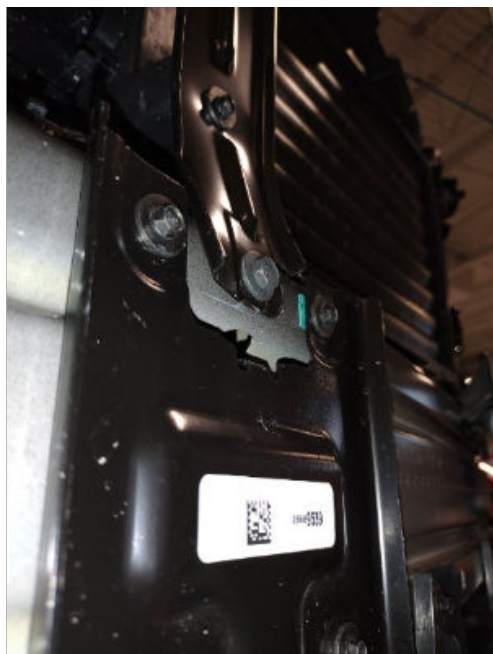
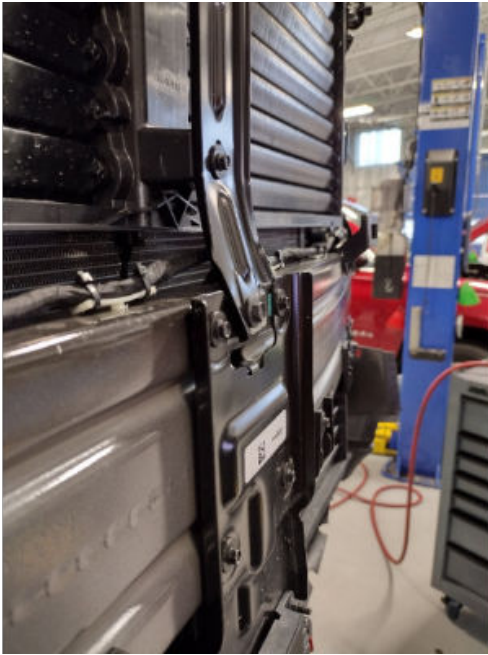
| <b>Condition</b> | SES light on with code P059F set for active grill shutter malfunction. |
| <b>Cause</b> | Possible bent hood support front bumper bracket. |

Before replacing the grill shutter inspect the bracket in front of it for being bent as shown below.

If the bracket is bent, remove the bracket and command the shutter with GDS2.

If the shutter will move when commanded replace the bracket.

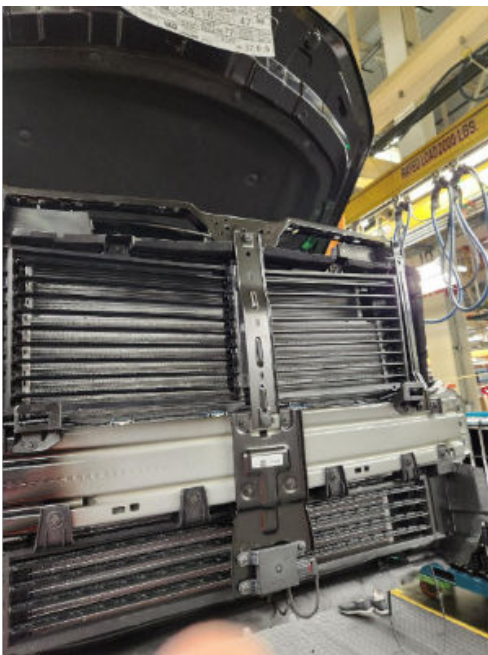
6719671

See the photo below of a good bracket for comparison.
