# Service Bulletin

Bulletin No.: PIP6060A

**Subject: Diagnostic Aids For 8-Speed Transmissions With Shudder or Surge While Driving On Highway**

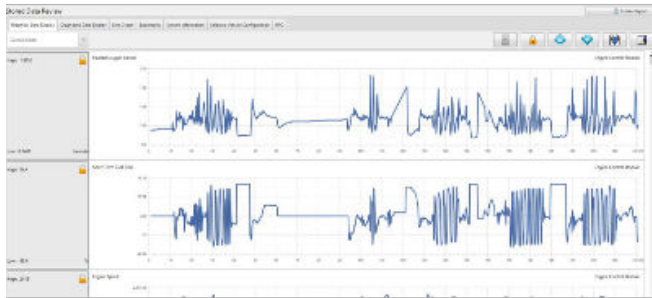
6877858

If the a concern is not isolated with converter diagnostics inspect the HO2S Sensor 1 (Pre-Catalyst) Lambda and STFT (Short Term Fuel Trim) for rapid fluctuations.

Suspect HO2S Sensor 1

If none of the above concerns are found or P064D is set please replace the HO2S Sensor 1 (Pre-Catalyst) sensor and re-evaluate the concern.

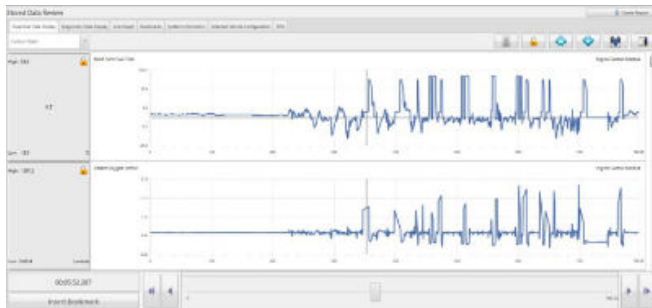
6877860

Known Good HO2S Sensor 1

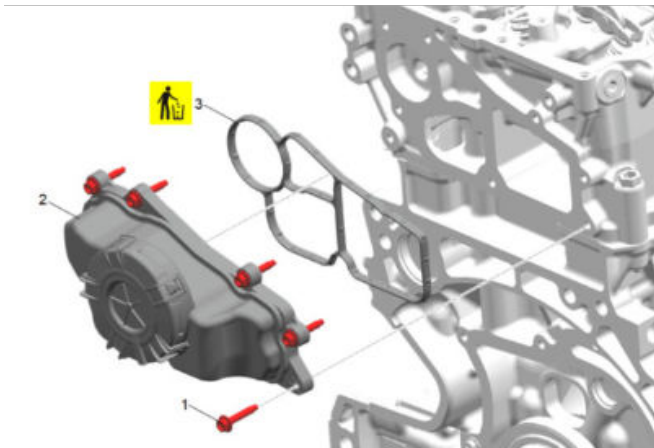
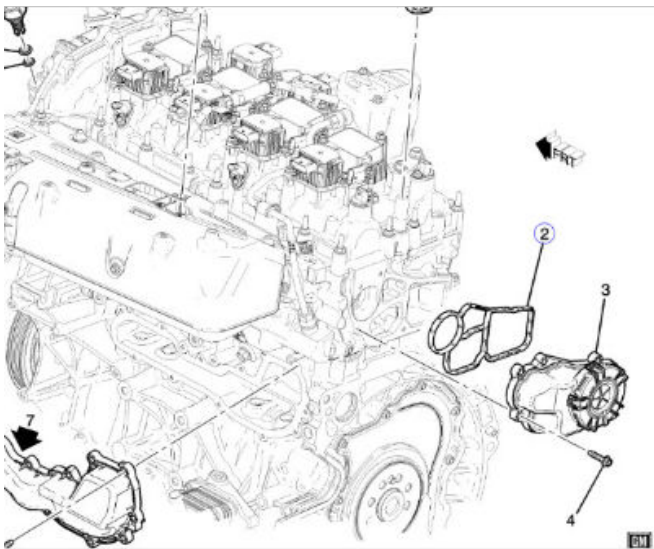
If excessive crankcase vacuum or pressure is seen, or there is evidence of oil consumption inspect for a damaged fine oil separator for damaged internal valves or the valves not fully seating.

The Fine Oil Separator is located on the back of the cylinder head NOT the camshaft carrier. Please refer to the pictures below

If a damaged fine oil separator is found verify there is not a mechanical concern with the engine.

If no mechanical concern exists then replace the fine oil separator and re-evaluate.
