| <b>Topic</b> | DTC P14AB00 and/or other related exhaust flap DTC's - Warning lamp evident within the DIP |
| <b>Brand</b> | Bentley |
| <b>Transaction No.</b> | 2055664/4 |

### Bentayga V8 Kovomo and Bentayga W12 TSI

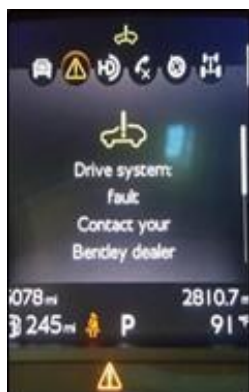
- Referring to Figure 1 - Warning lamp illuminated within the Drivers Information Panel (DIP)

- DTC P14AB00 and various DTC's evident within the Engine control modules 1 and/or 2 regarding exhaust control unit mechanical malfunctions
- Abnormal noises from the exhaust system
- This issue is applicable to both Standard and Sports exhaust systems

- The warning lamp and DTC's can be triggered by non-operation of the exhaust flap control unit/s

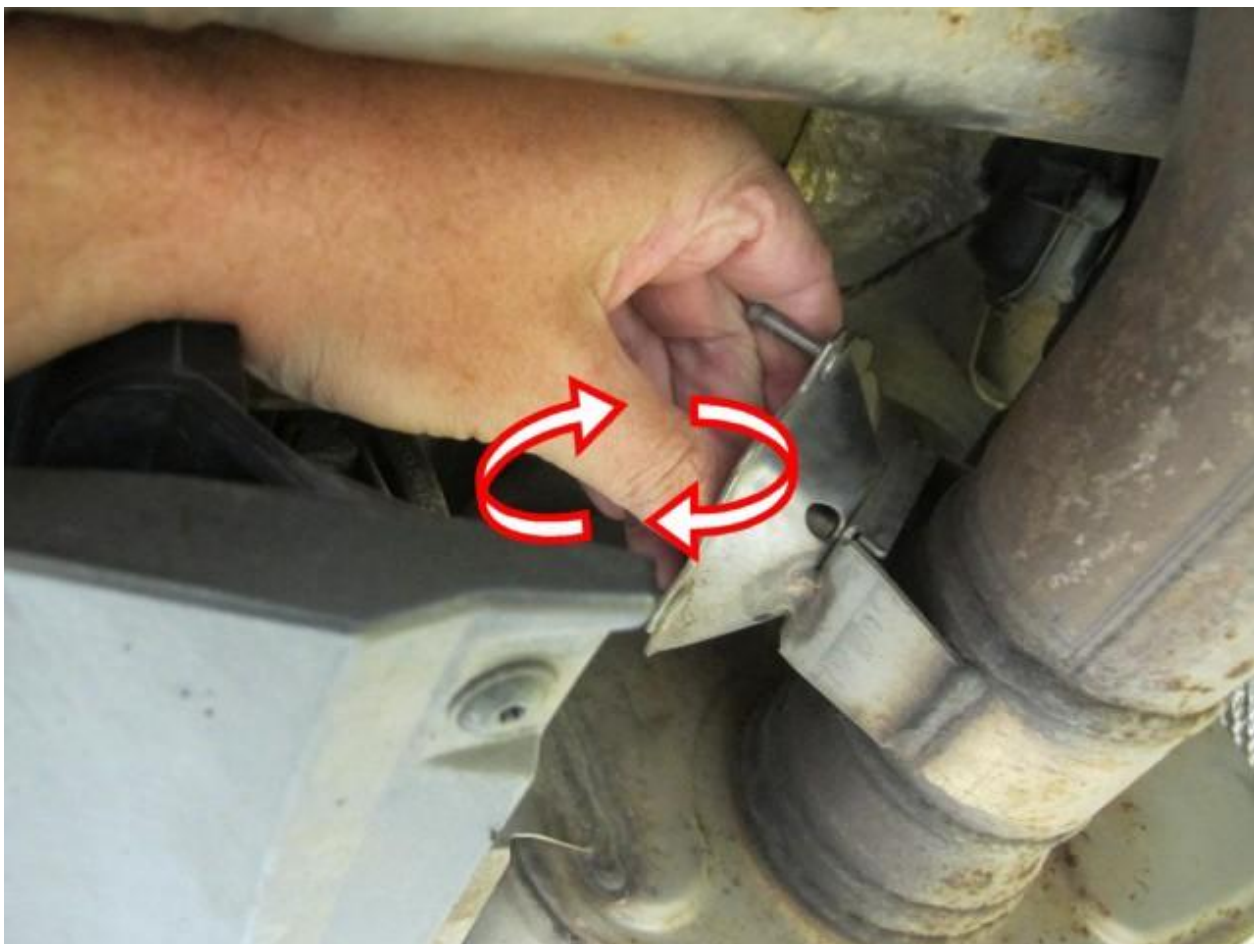
Figure 1

- Check and confirm the exhaust flap can be rotated by hand (clockwise and anti-clockwise) without the control unit fitted (Figure 1)

- Should no issue be evident with the exhaust flap and it can be freely rotated by hand - Replace the defective exhaust flap control unit Refer to Rep.Gr 26
