| <b>Topic</b> | Lower and/or upper front suspension lever bushes - Warranty replacement guidelines |
| <b>Brand</b> | Bentley |
| <b>Transaction No.</b> | 2075041/4 |

### Bentayga Series

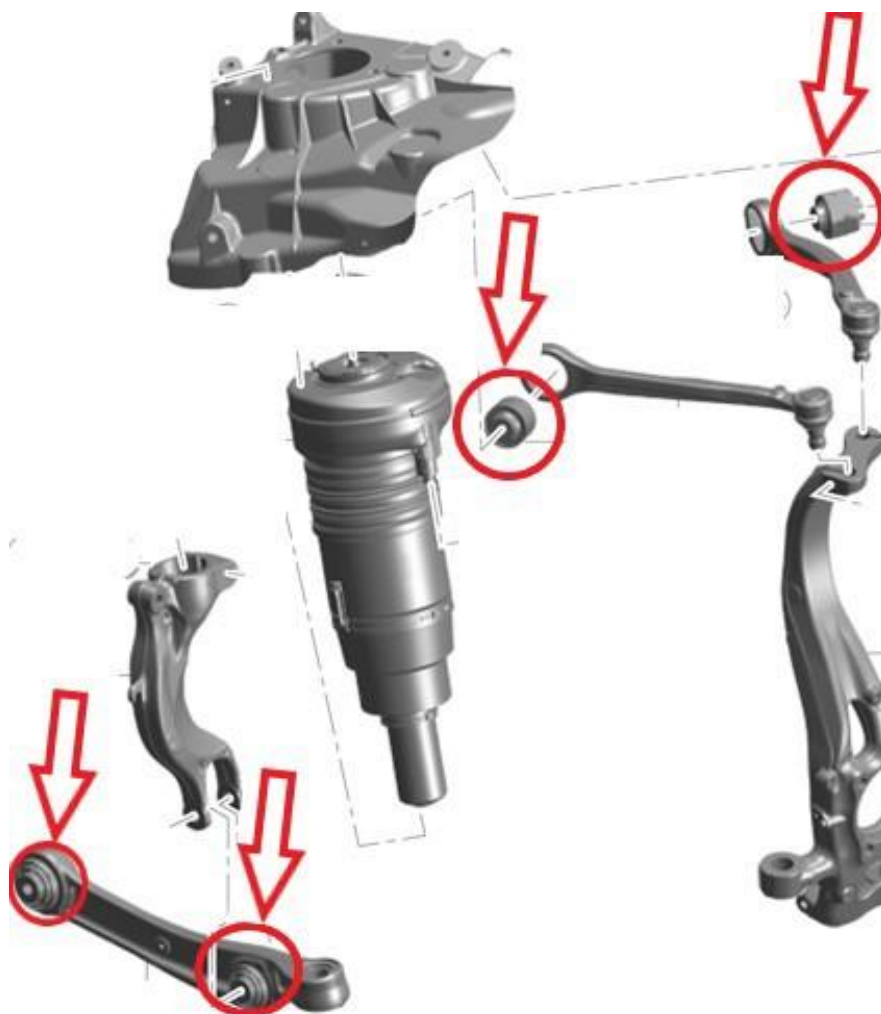
The left or right hand front lower and/or upper lever bushes (Figure 1) are exhibiting minor cracks (on inspection)

Before proceeding with replacing any of the lower and/or upper lever bushes shown in Figure 1 the operative must refer to the Technical background section of this TPI

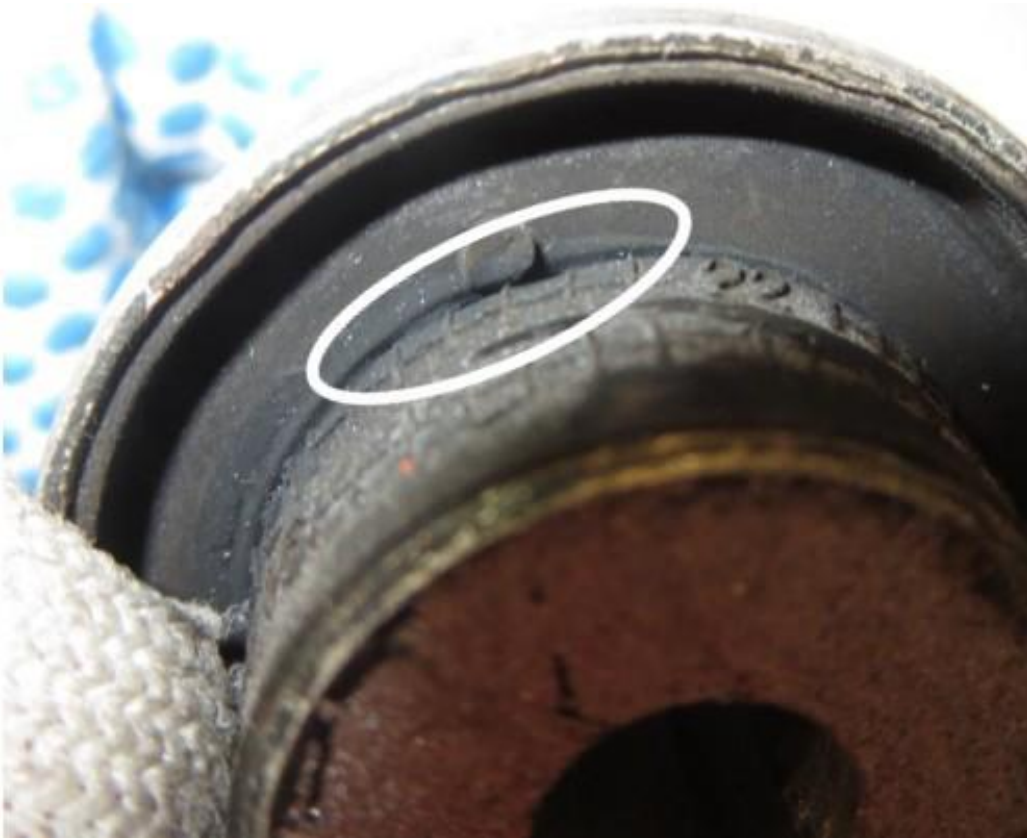
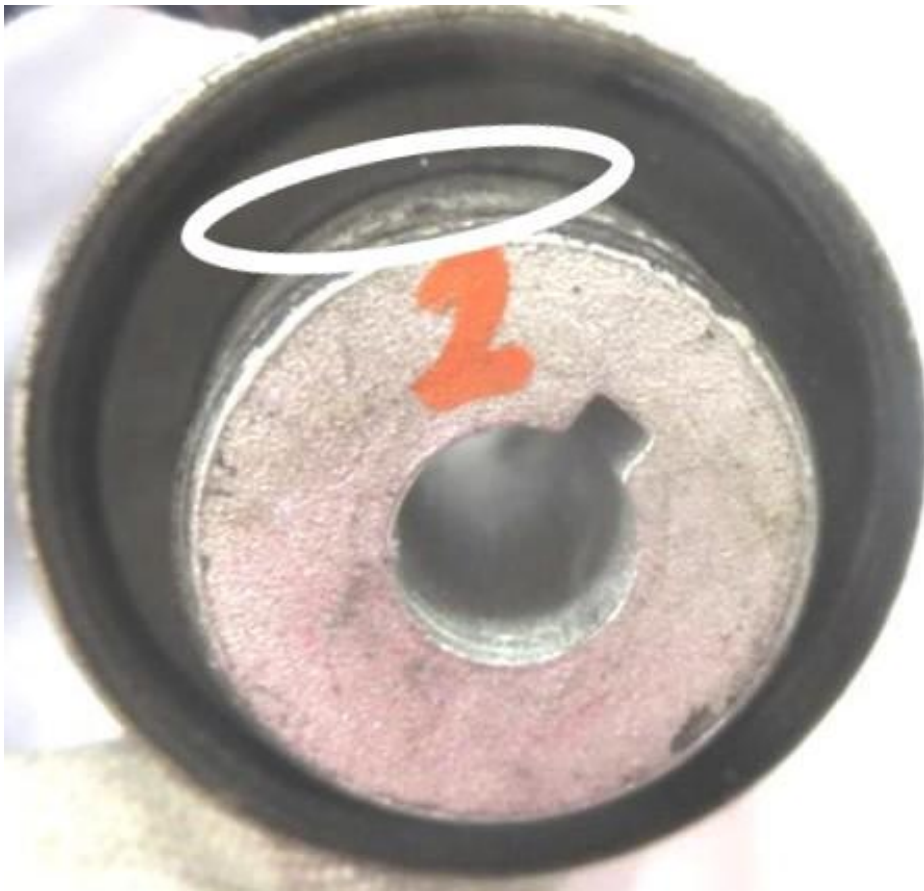
Should the bushes be in the condition shown in Figure 2 and 3 replacement is not required unless a customer complaint has been received relating to suspension noise - bush wear or overall serviceable condition
