## SIB 17 01 26

### DELIVERY STOP: CHECK AND IF NECESSARY, REPLACE THE CHARGE AIR COOLER VENT LINE

2026-07-10

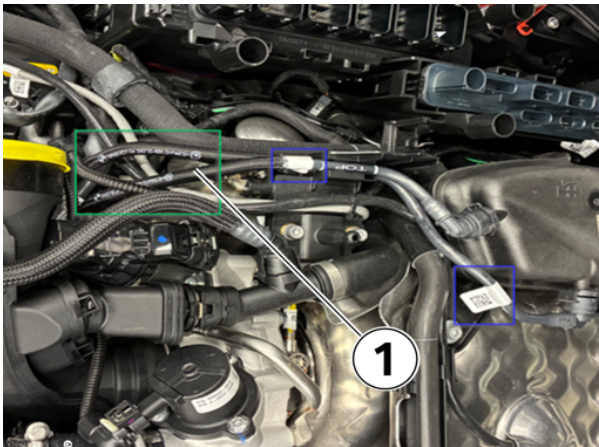
2. Check the Index number on hose PN 5A054D7 and 5A05798 (1), located within the marked boxes.

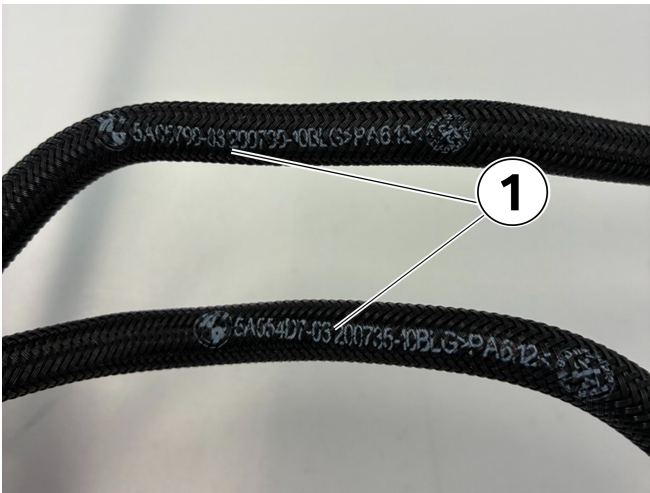
3. The index number is the two digits after the PN (1). NOTE: Example shows index AI-03

4. Are the lines indexed AI-04 or higher? Yes, go to step 6. Index lower than AI-04? Go to Step 5.

5. Replace the affected line/s.
