SIB 51 07 26

SERVICE ACTION: REPLACE DOOR LATCH MOUNTING BOLTS

| E-Series | Model Description | Production Date |
|---|---|---|
| G05 | X5 Sports Activity Vehicle | November 19, 2019 – February 13, 2025 |

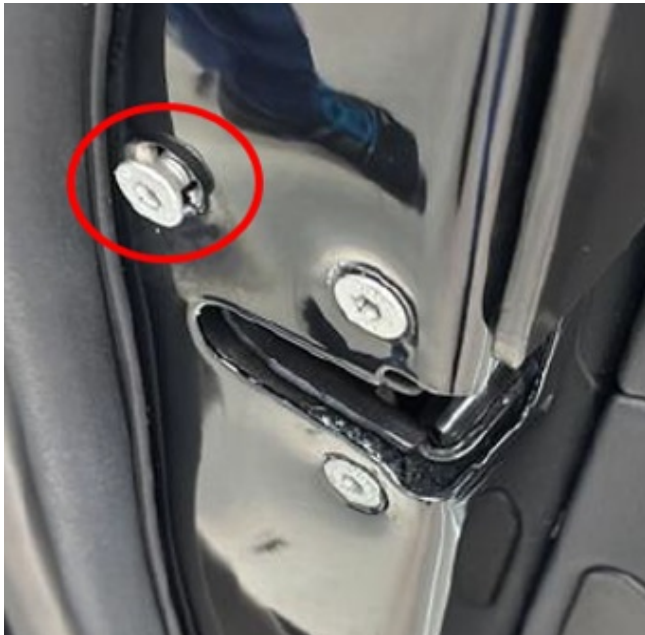
In the affected vehicles, an incorrect screw locking device (circled) may have been used for the mounting bolts of the door latch locks.

Over time, one or more mounting bolts of the door latch lock could loosen, causing rattling noises.

Replace the mounting bolts of the door latch lock on all four doors.

Replace the mounting screws (12 screws in total) on all four doors using repair instructions 51 21 092 (front door lock ...) under Section 13 Door Lock... and 51 22 090 (rear door lock ...) under Section 5 Door Lock...

**Note:** All threads in the hinge lock must be cleaned with a suitable thread chaser. Blow out left behind residue with compressed air.
