SIB 51 08 26

SERVICE ACTION: CHECK FRONT DOOR TRIM PANELS

2026-07-02

| E-Series | Model Description | Production Date |
|---|---|---|
| G20 | 330i, 330i XDrive, M340i, M340xD | 4/9/2026 – 4/20/2026 |

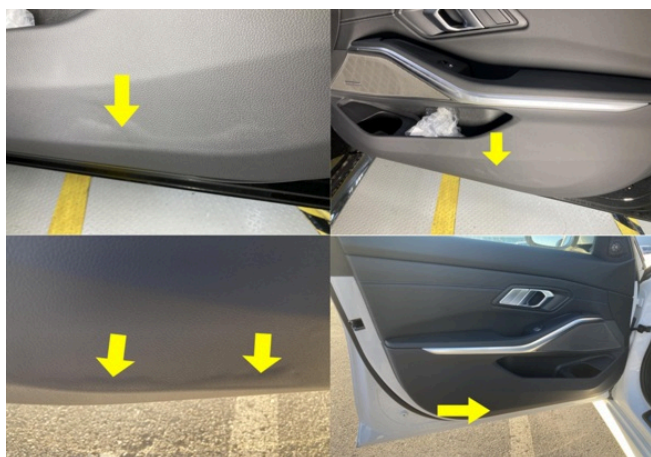
Check whether there is any separation or bubble of the vinyl surface on the front door trim panels.

If no separation or bubbles are visible, use your index and middle fingers attempt to drag the vinyl top layer up and down in the areas shown.

If a noise is heard or the vinyl top layer is moving, the trim panel must be classified as not OK and the affected door trim panel replaced in accordance with **Repair Instruction 5141001 "Replace left or right front door trim panel"**
