| Topic | Headlamp Control Unit Replacement Bentayga and Flying Spur |
| Transaction No. | 2071933/5 |

Headlamp Control Unit Replacement | Bentayga and Flying Spur

Transaction No.: **2071933/5**

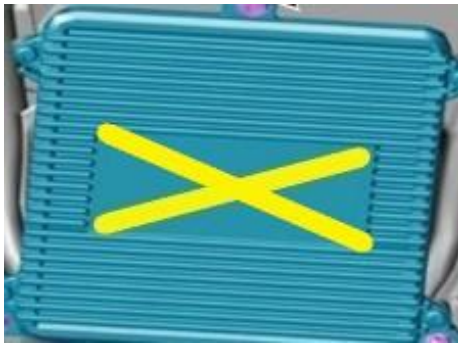
Figure 1

The headlamp control unit can only be replaced a **MAXIMUM** of **TWO** times (per headlamp) If there are two yellow paint marks on the control units (Figure 1) or the vehicles repair history shows the control units have been replaced **TWICE**, a new headlamp assembly is required
