| <b>Topic</b> | Loss of Cabin Heat During Engine Operation Bentayga - V8 |
| <b>Transaction No.</b> | 2081236/2 |

Loss of Cabin Heat During Engine Operation | Bentayga - V8

Release date: 16 Jul 2026

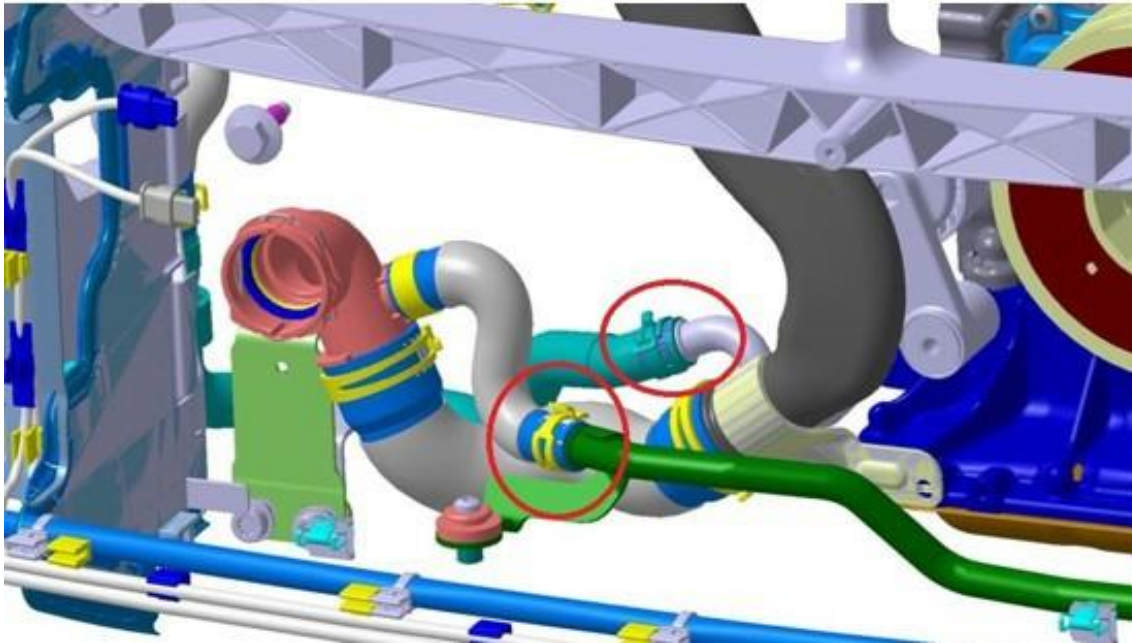
Further inspection may reveal that two coolant hoses in the engine bay have the incorrect routing.

The heating issue can be caused by two coolant hoses being reconnected in the wrong positions during previous repair work. Incorrect routing prevents hot coolant from flowing through the heater matrix while the engine is running, resulting in cold HVAC air. This is a repair induced issue, not a manufacturing defect.

**Figure 1.** *Coolant hose inspection (correct orientation)*

3. Inspect the two-coolant hose -circled-.

6. Reconnect hoses in their correct positions as shown in figure 1 & 2.

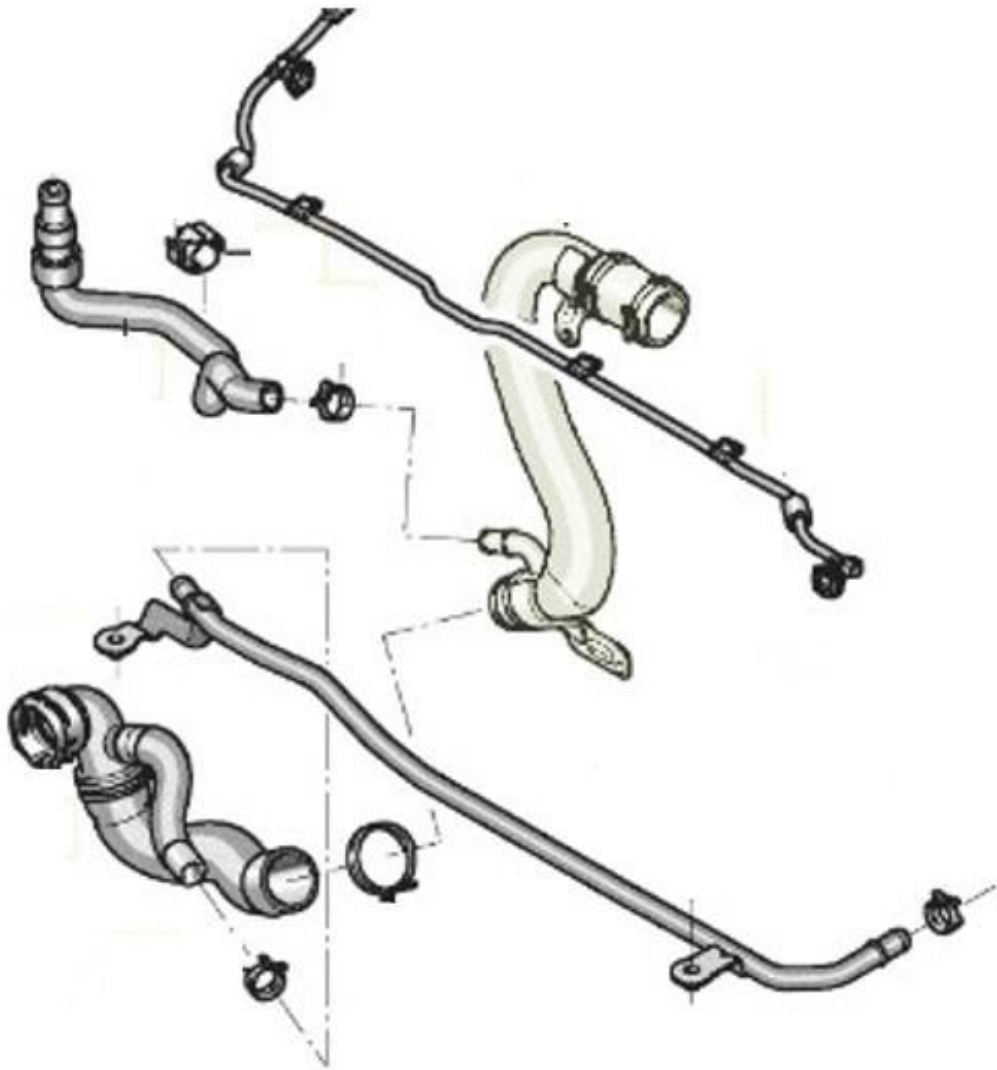
4. Use the diagram below to assist confirming correct hose fitment.

**Figure 2.** Correct coolant hose routing diagram
