## Technical product information

| Topic | Bentayga V8 Kovomo - Engine MIL light on - DTC "O2 Sensor Signals Swapped Bank 1 Sensor 2/ Bank 2 Sensor 2 |
| Transaction No. | 2065664/6 |
| Release date | 16 Jul 2026 |

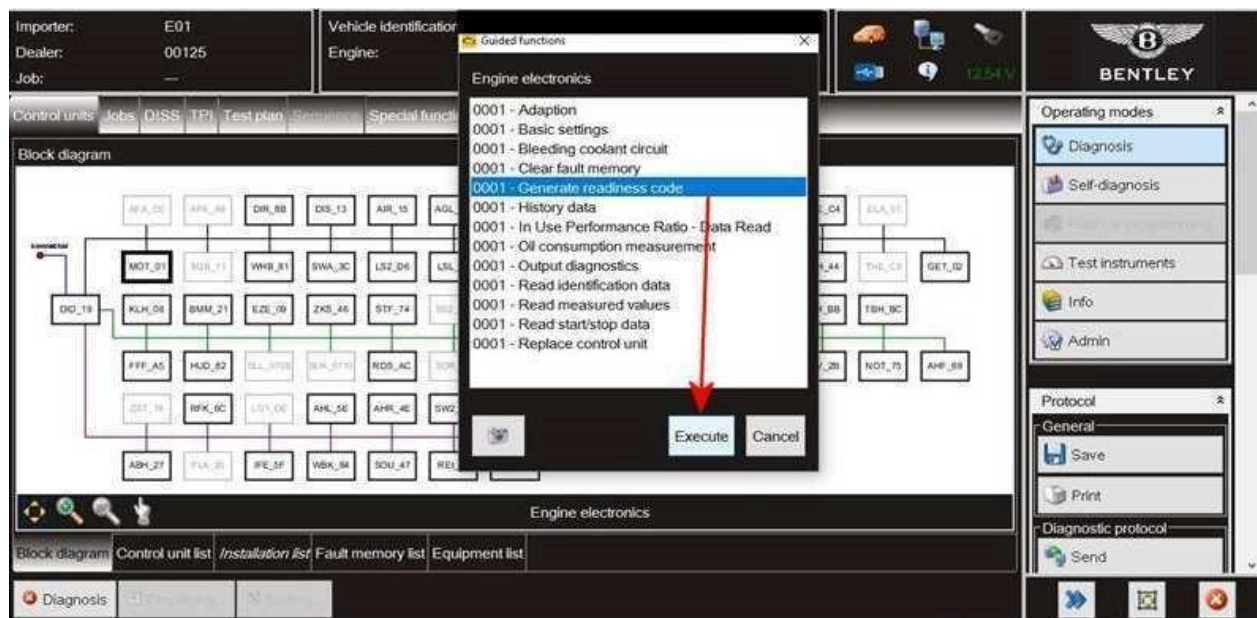
DTC P004100: "O2 Sensor Signals Swapped Bank 1 Sensor 2/ Bank 2 Sensor 2 is evident within address 0001 (Engine control unit) and MIL light active after attempting to conduct a readiness test

- Referring to Figure 1 - Select Guided functions from 01 - Engine Control Module 1
- Select Generate readiness code
- Select Execute and follow the readiness code procedure to completion as per all on screen prompts
